# 2023 Interim Bridge Inspection

PennDOT Bridge Inspection Report

Feature Carried: Mill Street

Feature Under: Delaware & Lackawanna RR

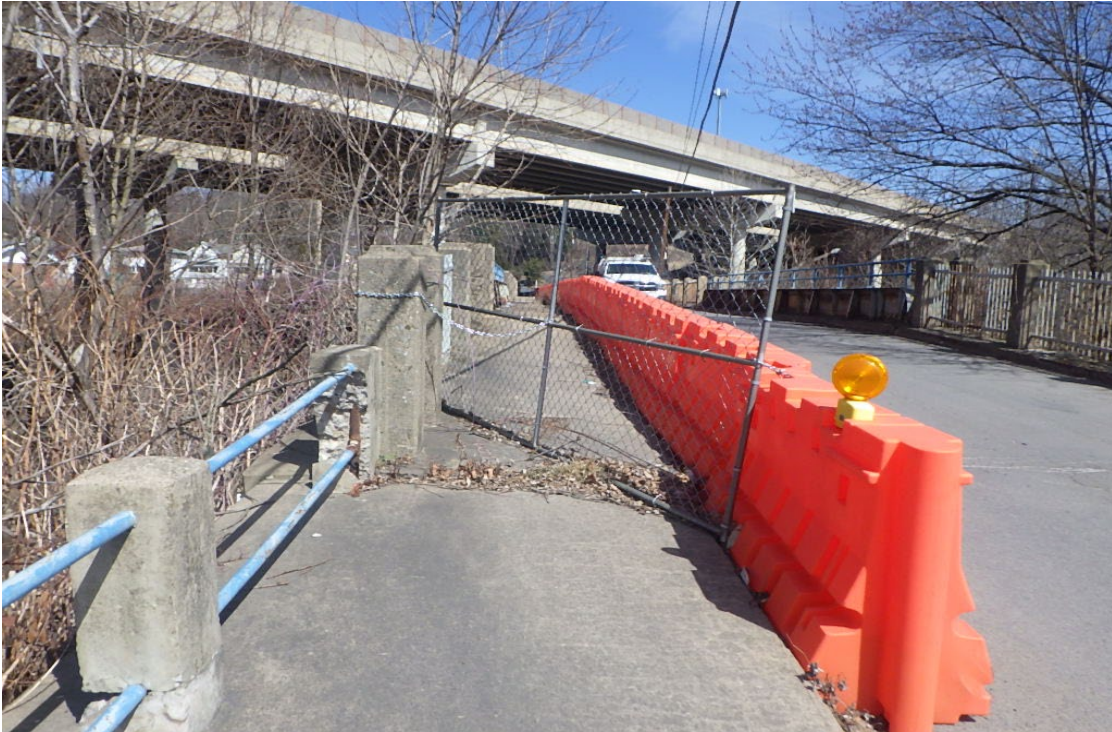
5. Closed sidewalk, Near Left Approach, looking ahead.

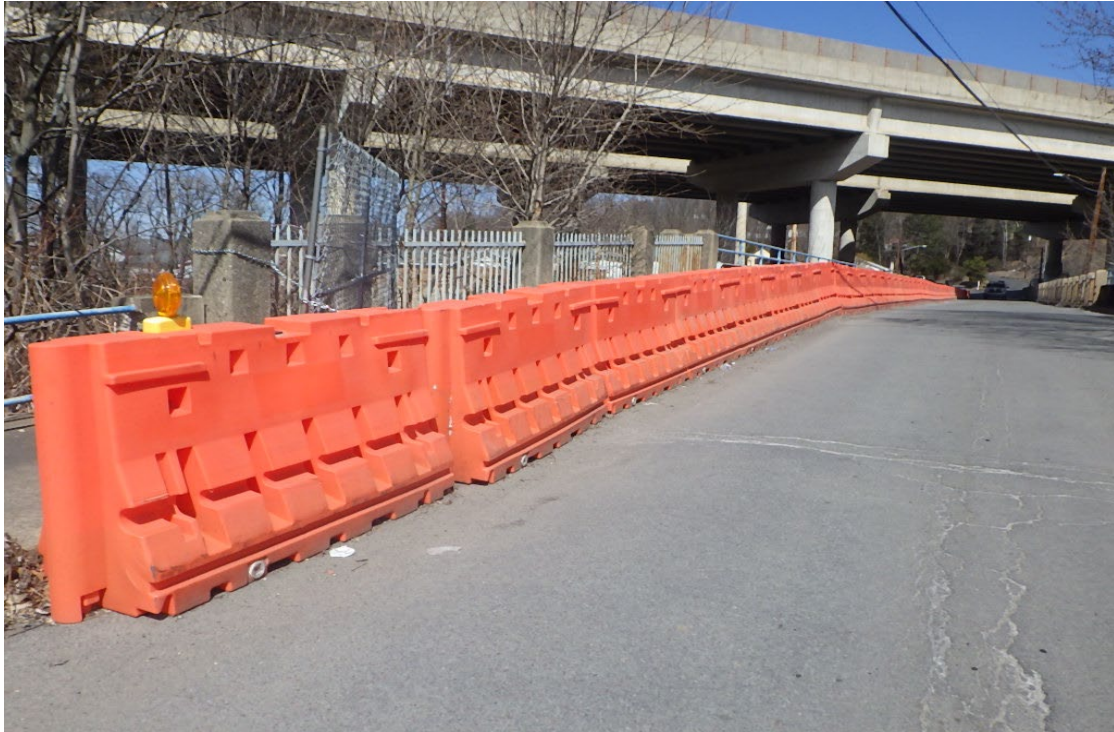
7. Left bridge rail and closed sidewalk, top of deck, looking left.

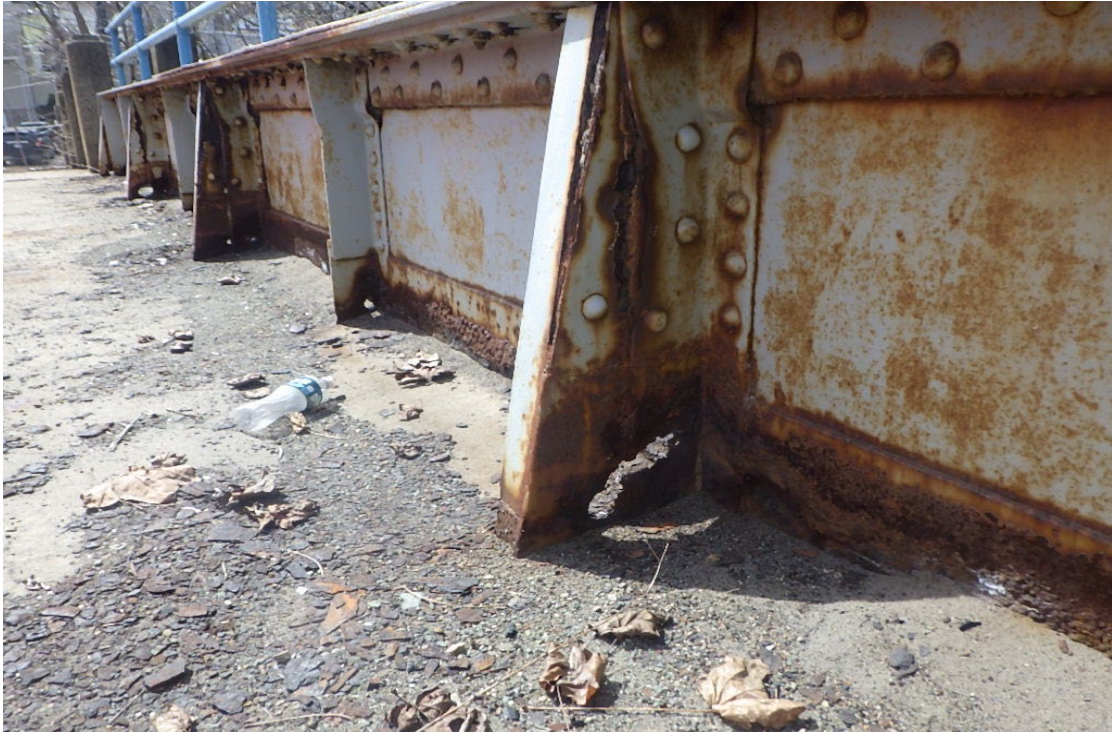
9. Left Girder with 100% section loss to the bottom of the stiffeners and knee brace webs.

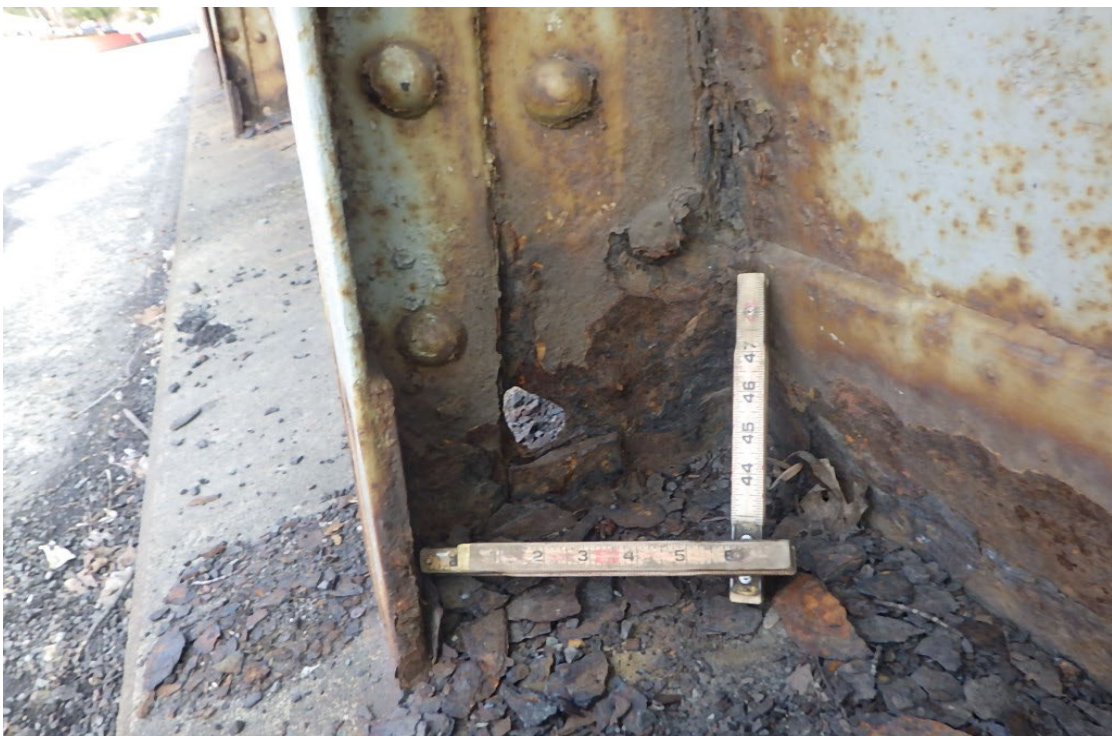
10. Hole in the web of the knee braces for the Right Girder.

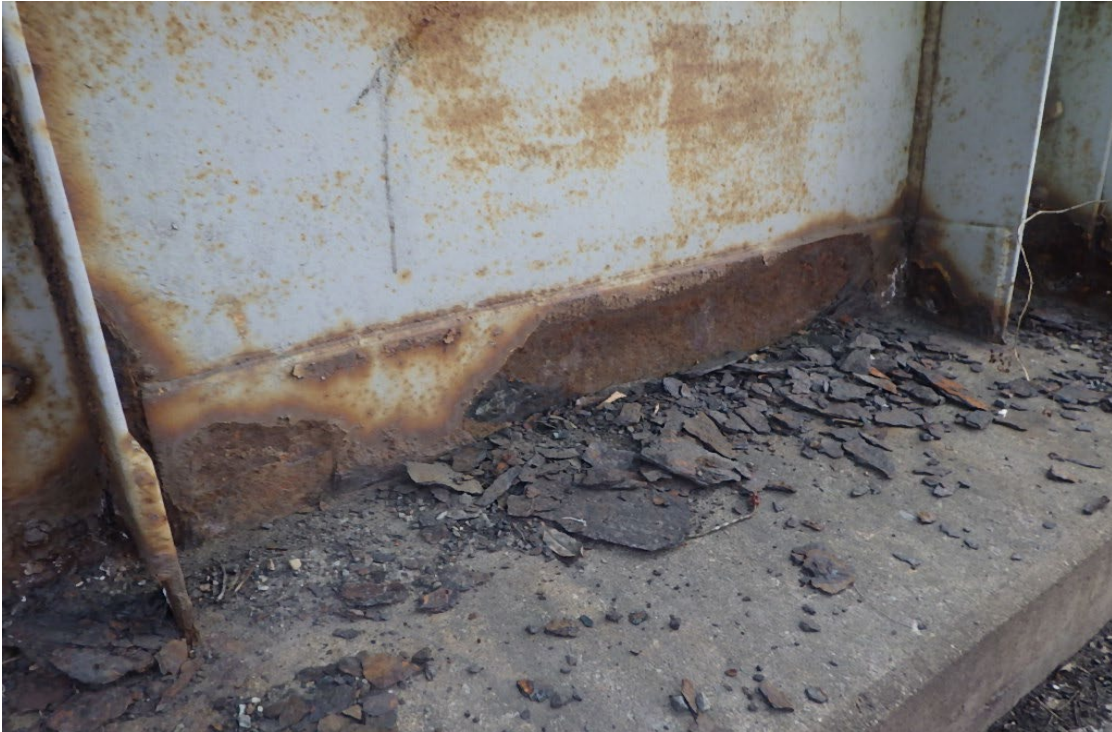
11. Typical section loss to the web plates along the Right Girder.

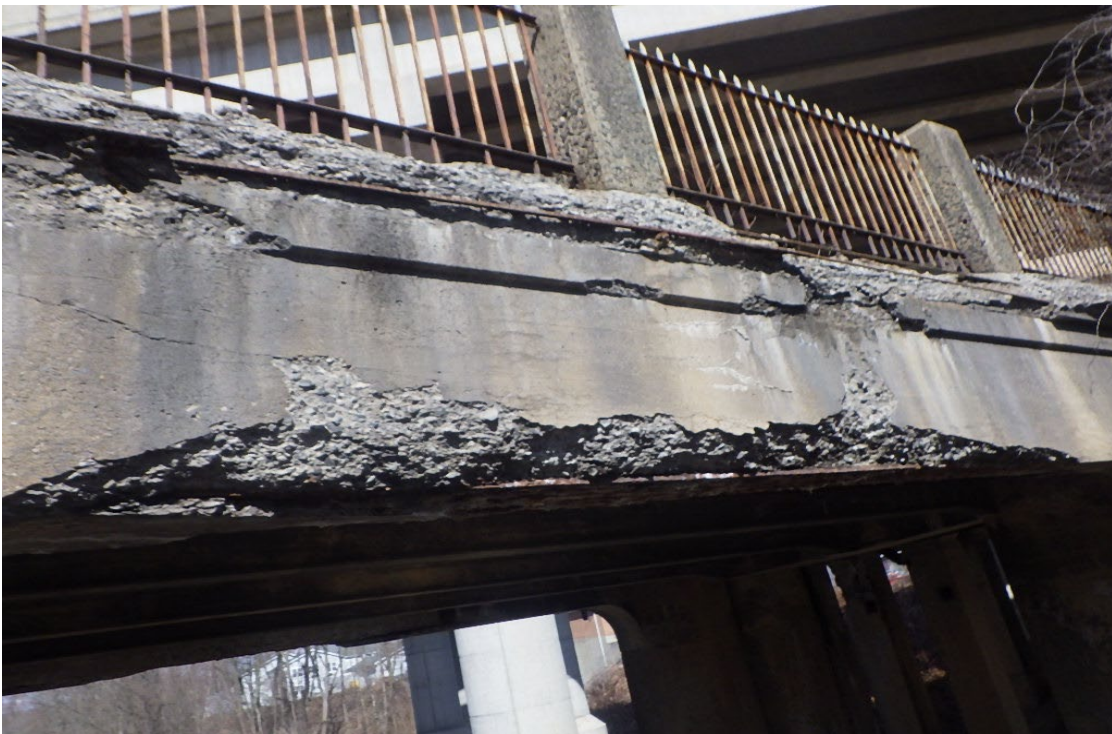
12. Areas of spalling with exposed rebar along the outside edges of the deck.

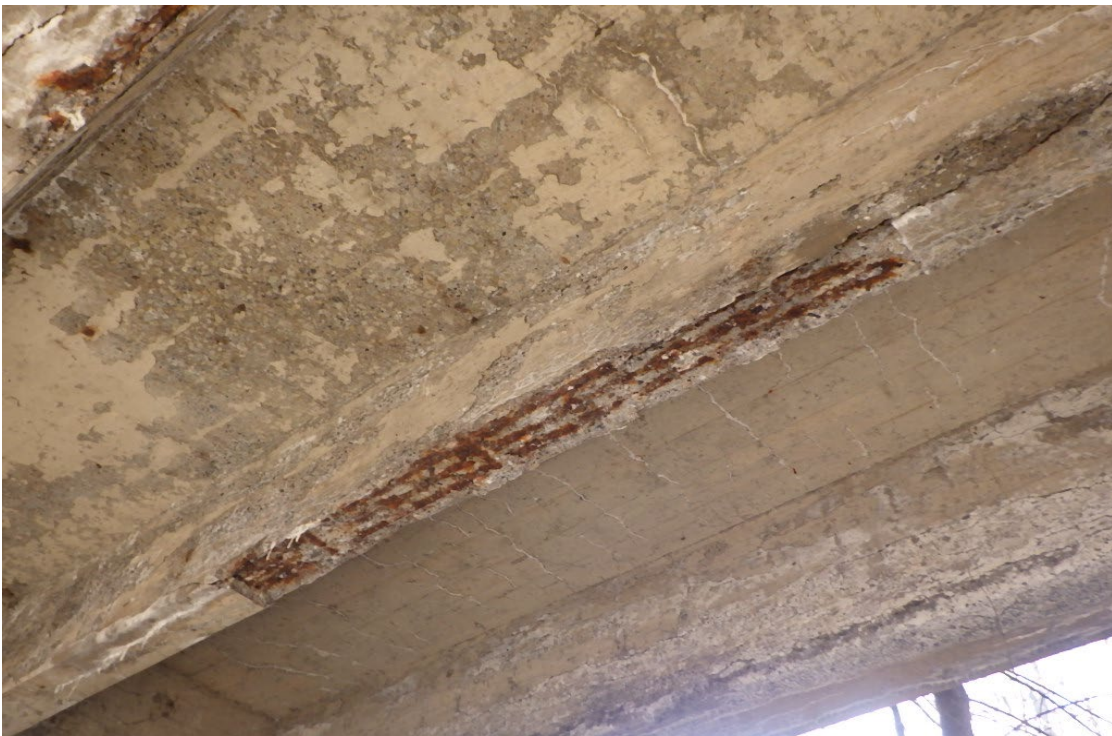
14. Beam 2, Span 1 with cracks, delamination and spalls with exposed rebar.

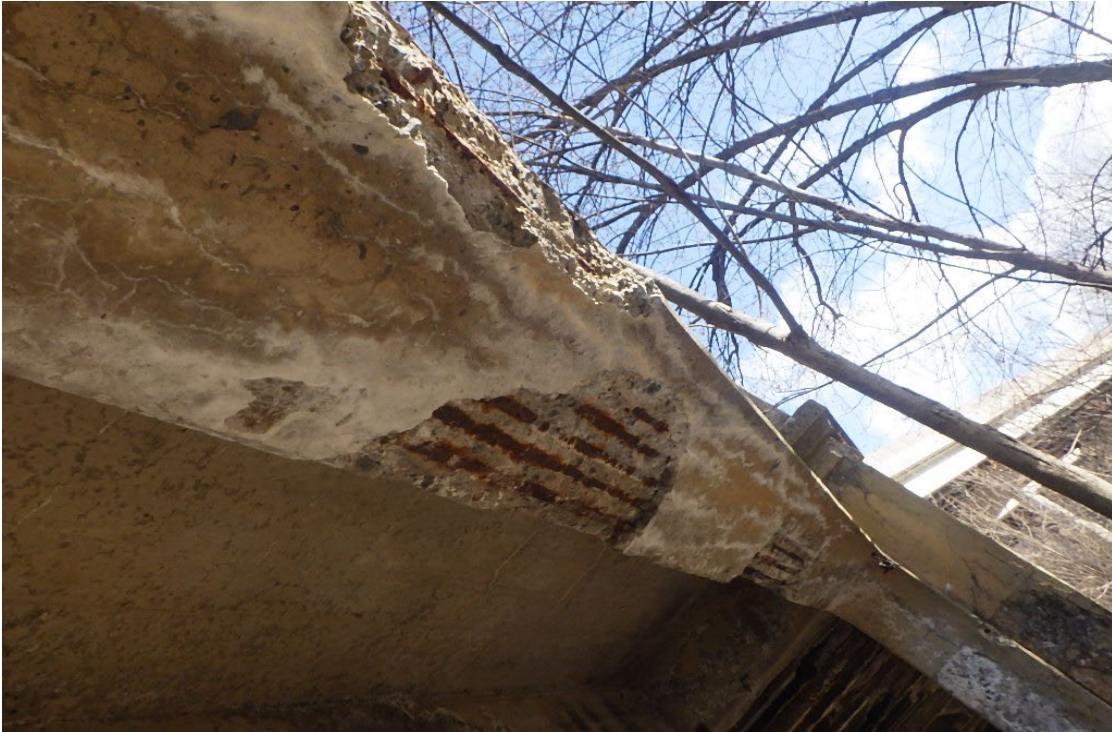
15. Beam 5 in Span 1 with spall with exposed longitudinal reinforcement near mid-span.

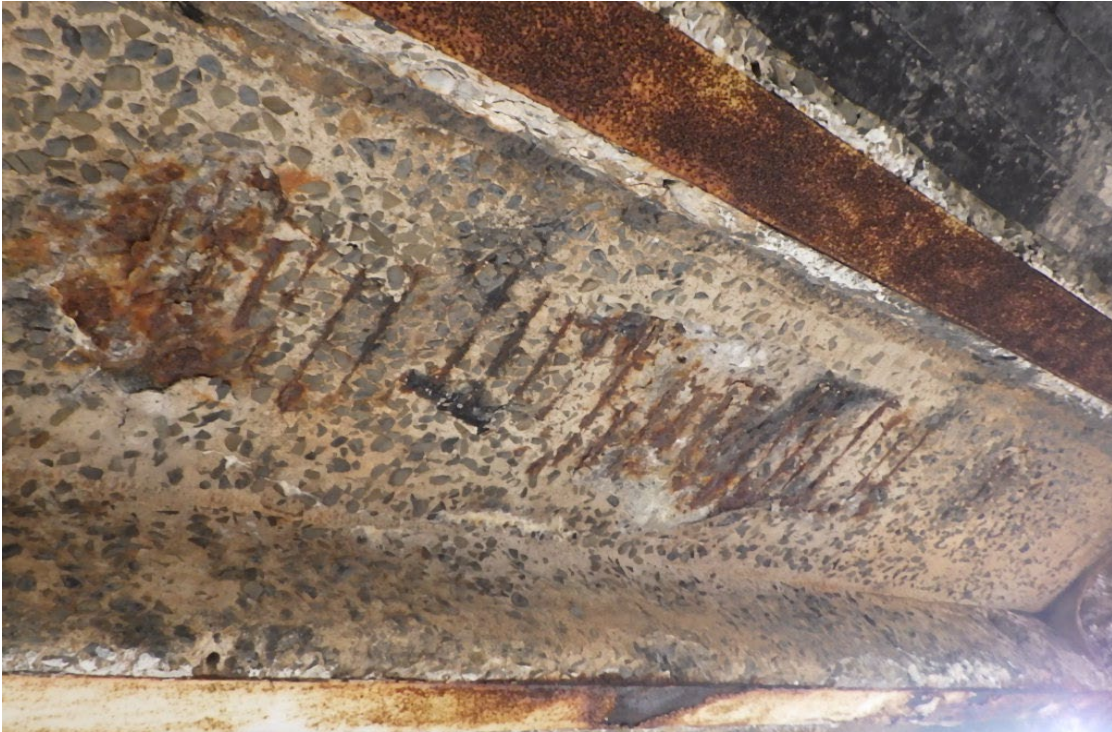
17. Spalls with exposed rebar in the underside of the deck in Span 2.

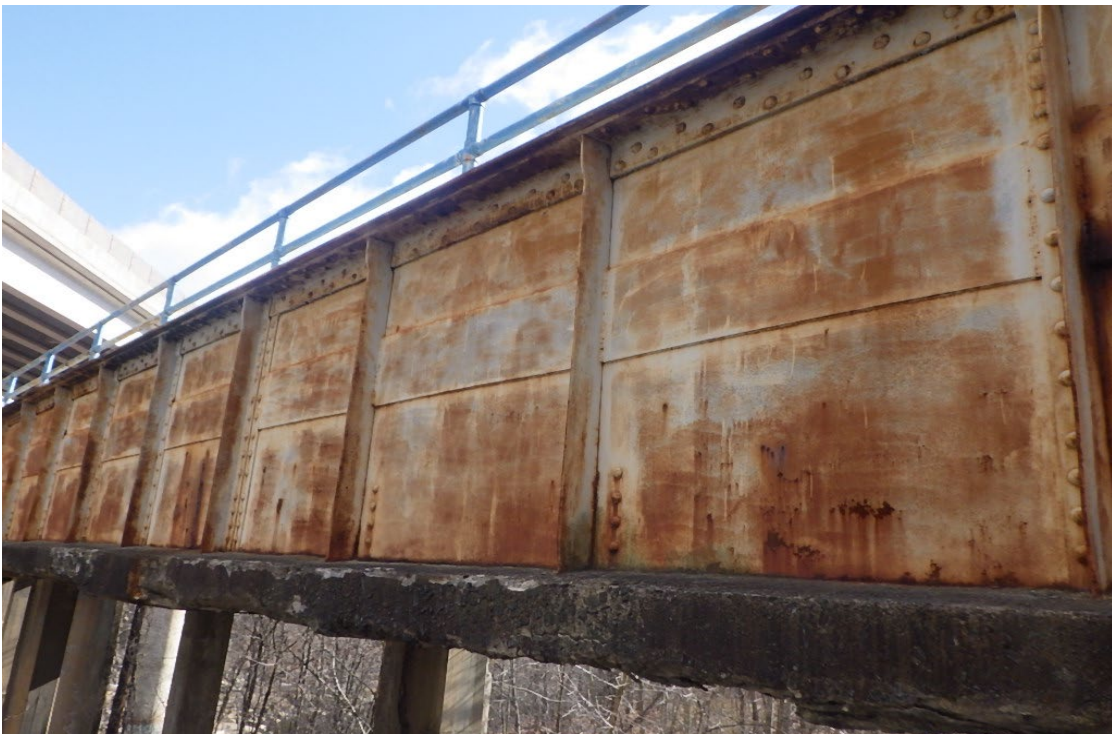
18. Typical moderate to heavy rust along the through girder webs.

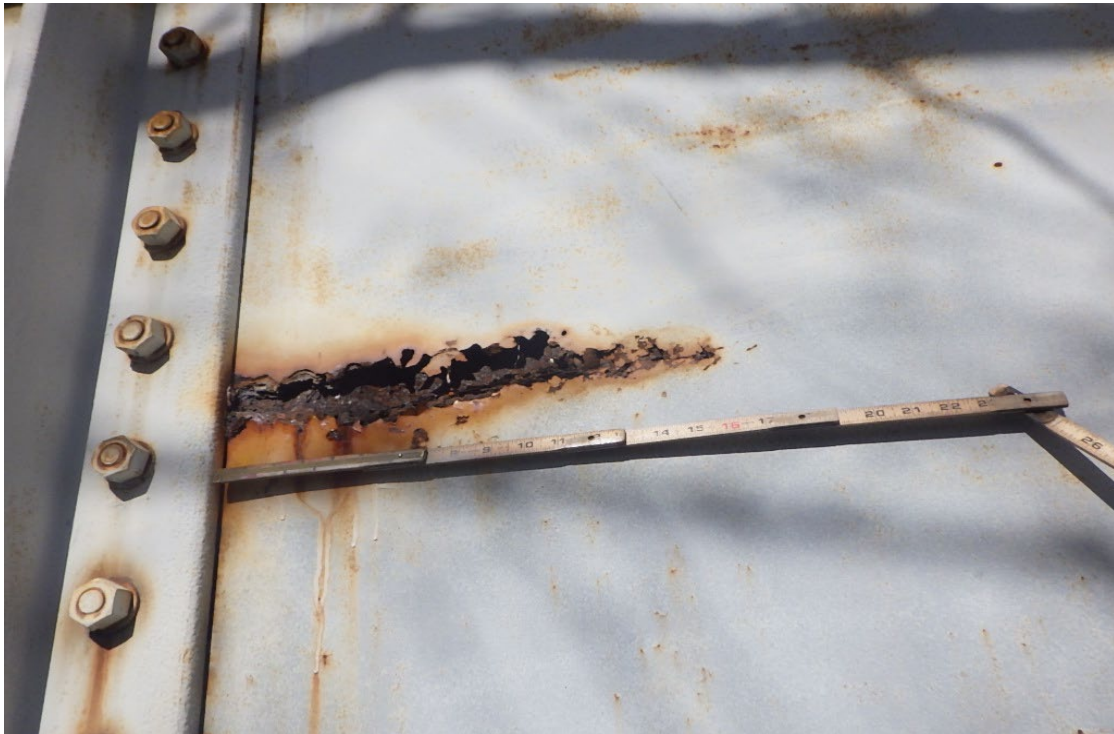
19. Hole in the web of the right girder at the near end.

- Isolated pack rust/prying @ longitudinal mid-height repair plates;
- 16" x 2" hole @ right (inside face repair plate visible through hole) at near end; 1" diameter in same location, near side of bolted angle
- 1-1/2" dia hole above floorbeam 6 @ right
- Severe rust with small holes at midheight right between FB 7 & 8
- 1" diameter hole in web at FB 11 @ right
- Near end right girder with 6"H to 3"H x 42"L x 3/8" SL to bottom of web
- Left exterior web, 5th stiff: 1/2" diameter hole at bottom
- At FB 13, right girder with 4"H x 2.5"L hole;

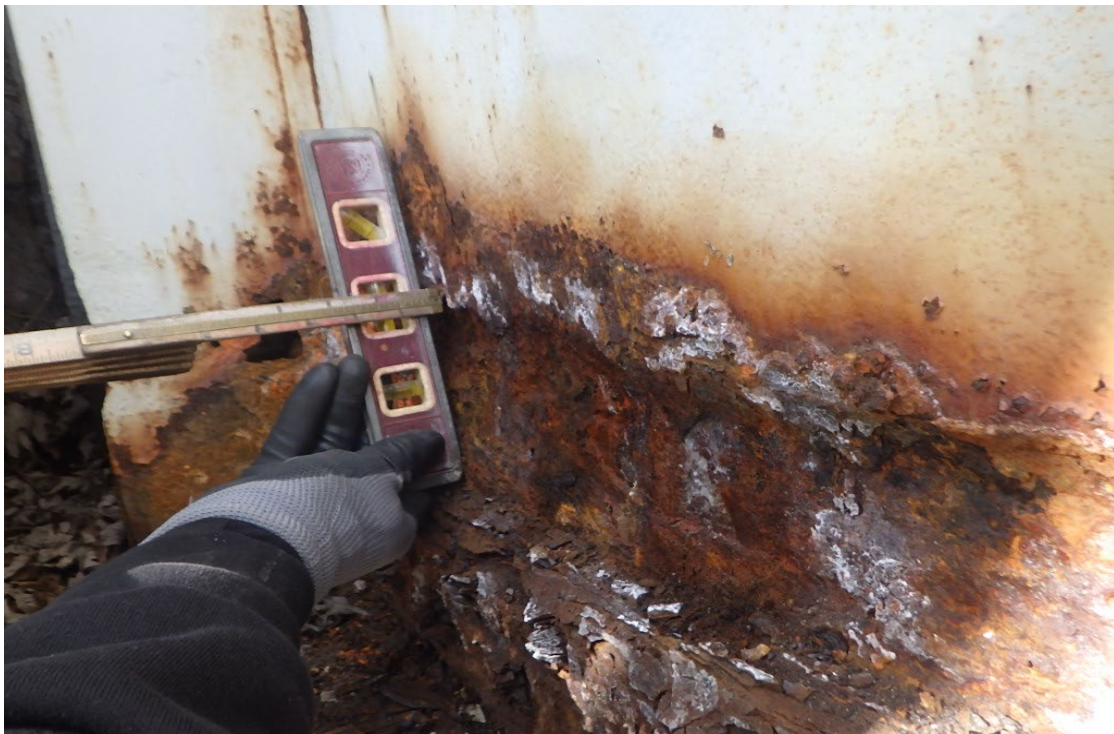
20. Advanced section loss to the bottom of the web of the right girder at the near end.

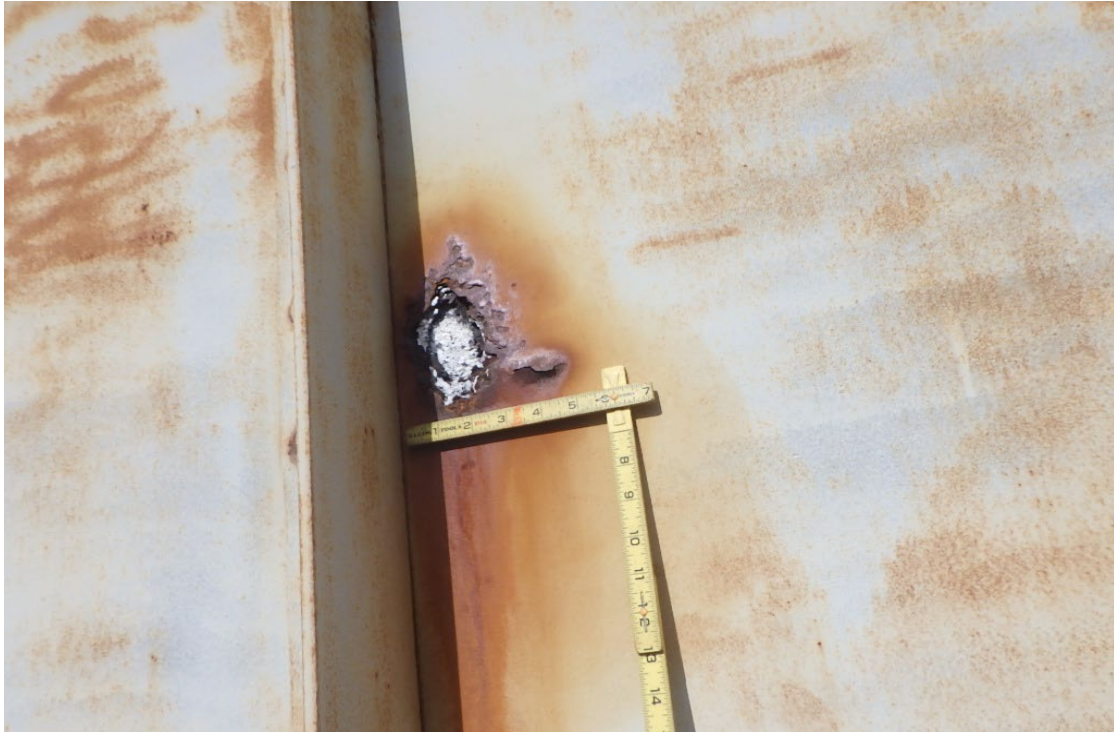
21. Newly noted hole in the Left Girder web at Floorbeam 13.

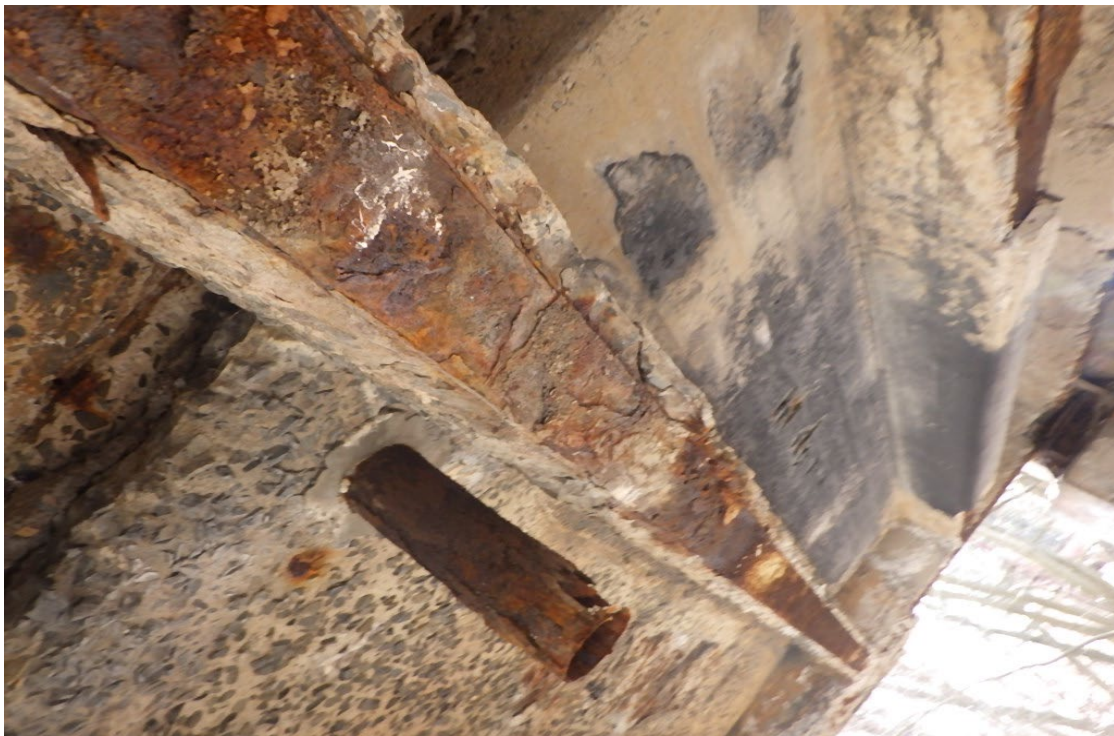
22. Span 2 floorbeams with spalled concrete exposing the bottom flanges.

- Heavily spalled concrete encasement;
- Heavy rust/minor loss where bottom flange exposed (mostly @ ends)
- Several rivets show heavy section loss

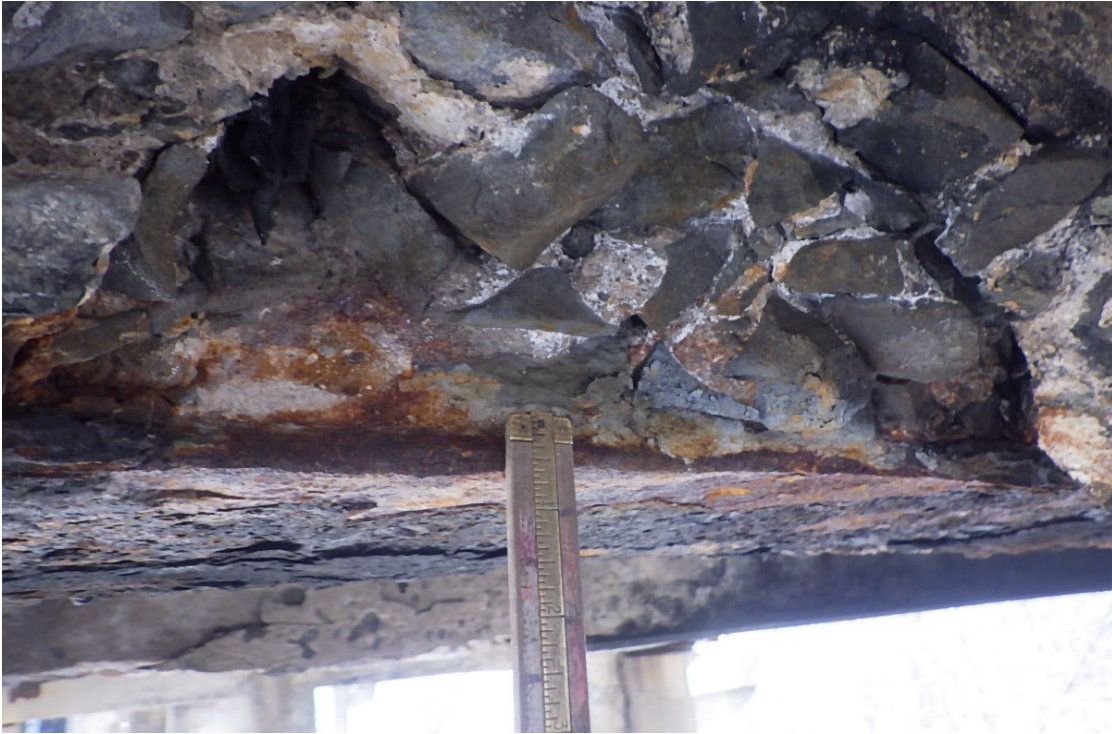
23. Close up of the floorbeam bottom flanges with rust and section loss.

- FB1, underside of bottom flange: 3/16" SL, measured at midspan.
- FB1, 3 - 7, 15: Full length bottom flange spalls
- FB2, 8 - 14: Heavy cracks/delamination, spalls @ ends
- Typical bottom flange section loss with 3/8" thick remaining at the top
- 5/16" thick remaining across underside of bottom flange
- Indeterminate bottom flange section loss due to encasement, moderate loss (worst) @ FB1 & 15 due to deck joint leakage (~ 3/8" remains at the flange tips, bottom interior portions of the flange has a 3/16" section loss (FB1) & up to 3/8" (FB15))

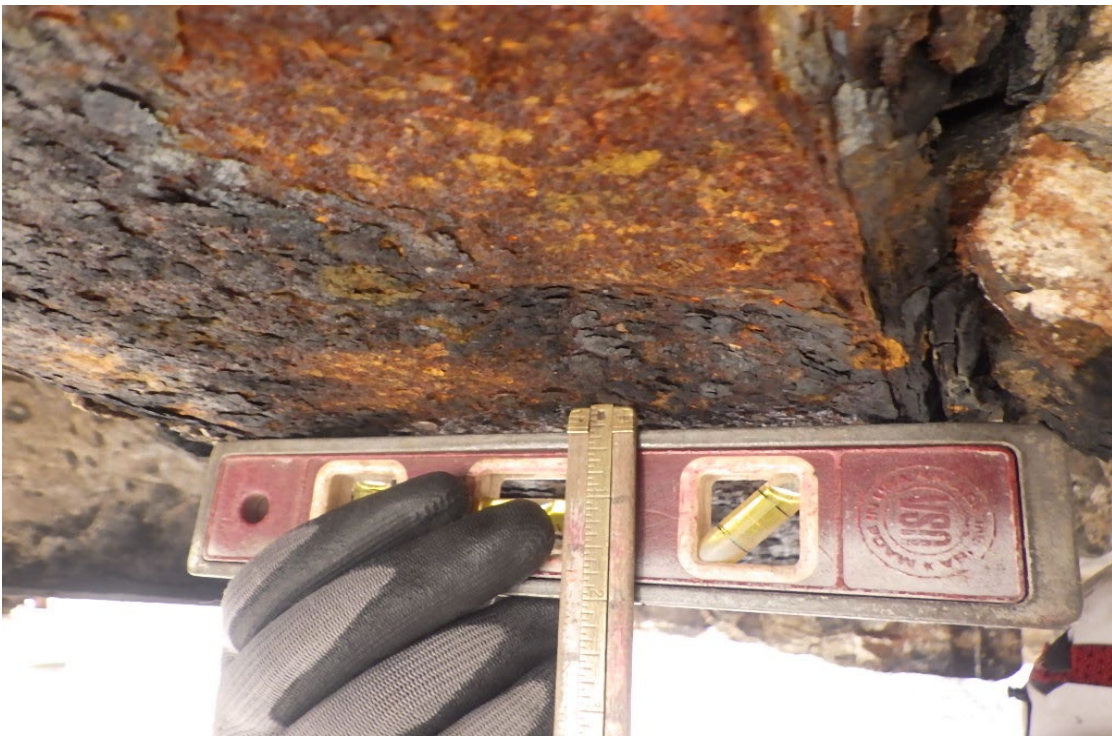
24. Section loss to the underside of the floorbeam bottom flanges.

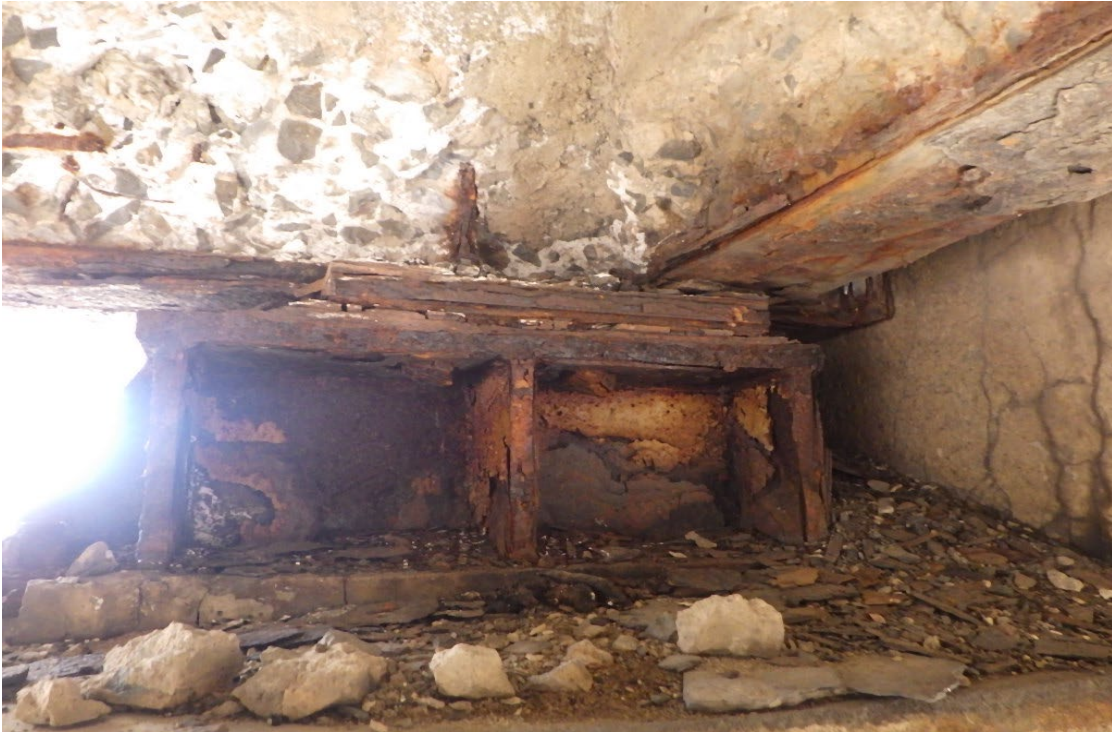
25. Girder bearings in Span 2 with heavy rust and pack rust. Note the bearings are frozen in expansion.

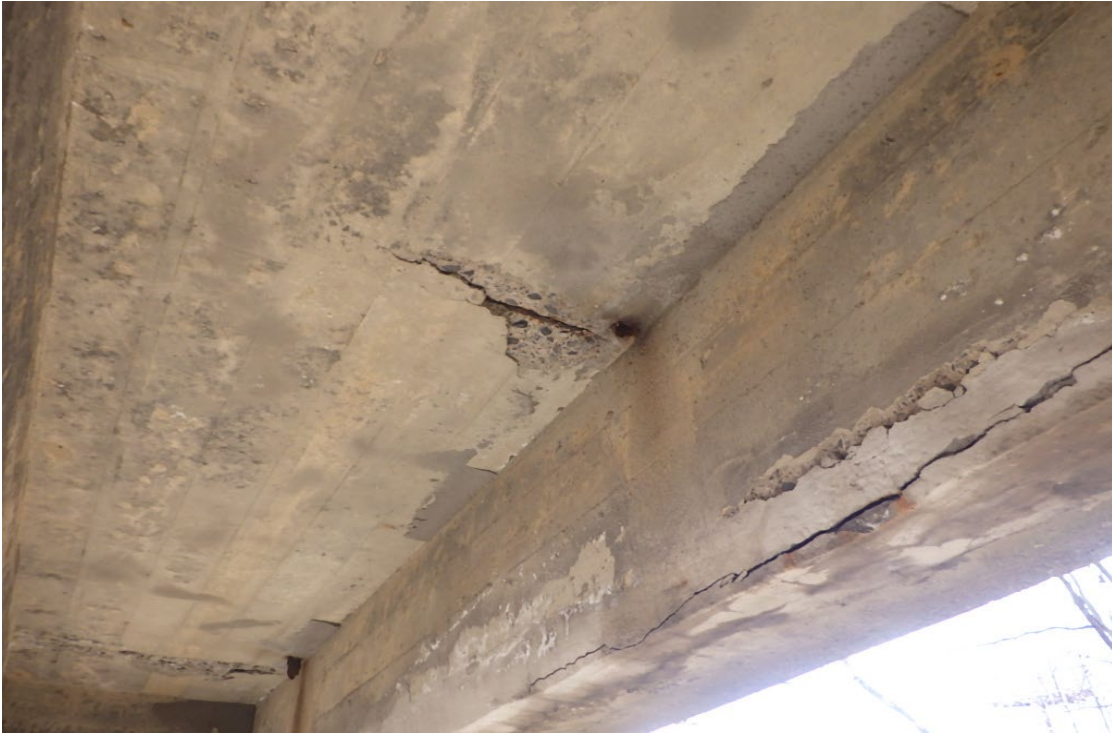
27. Spall with exposed rebar in the underside of the deck, Span 3, Bay 4.

T-beam Span 3:  
- Spall with exposed rebar, Bay 4, Span 3 (5 TSF)

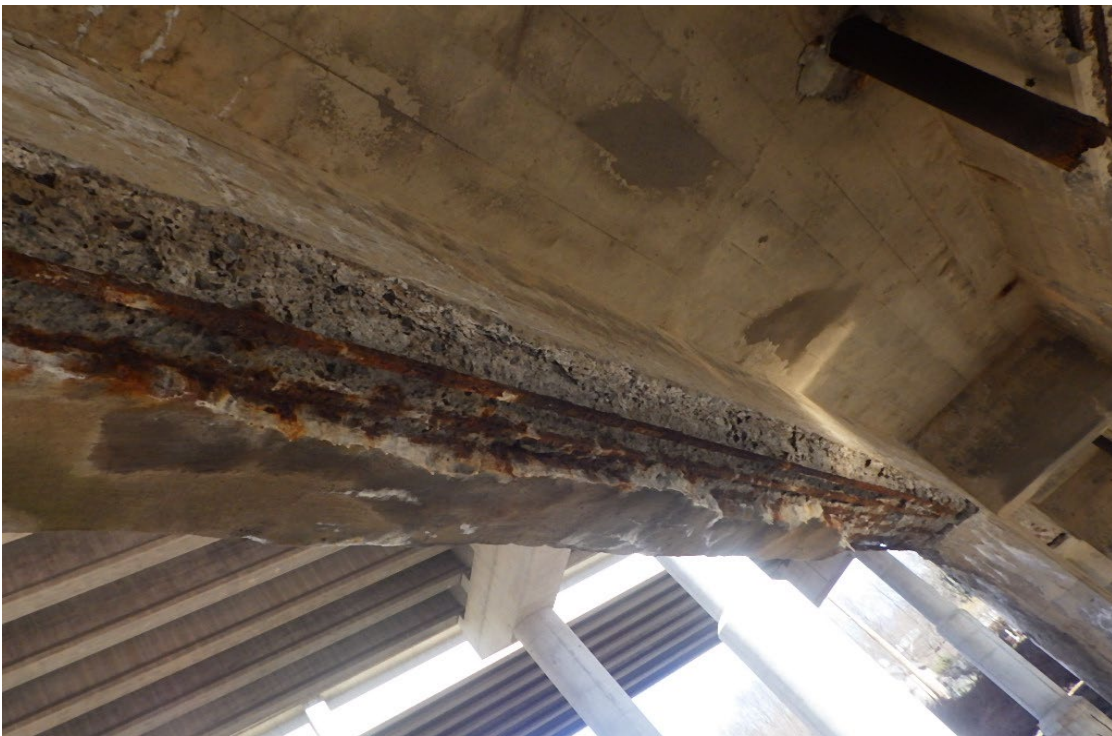
28. Span 3, Beam 1 spall throughout length with exposed and debonded rebar.

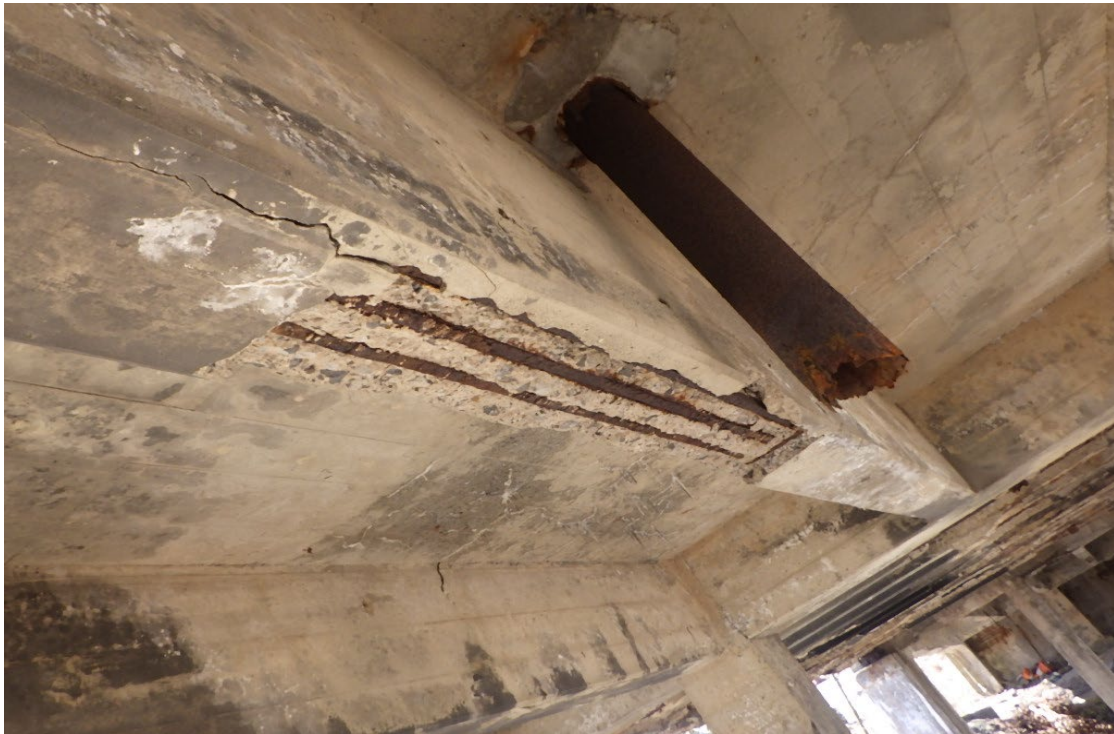
29. Spall with exposed rebar in the bottom of Beam 2 in Span 3.

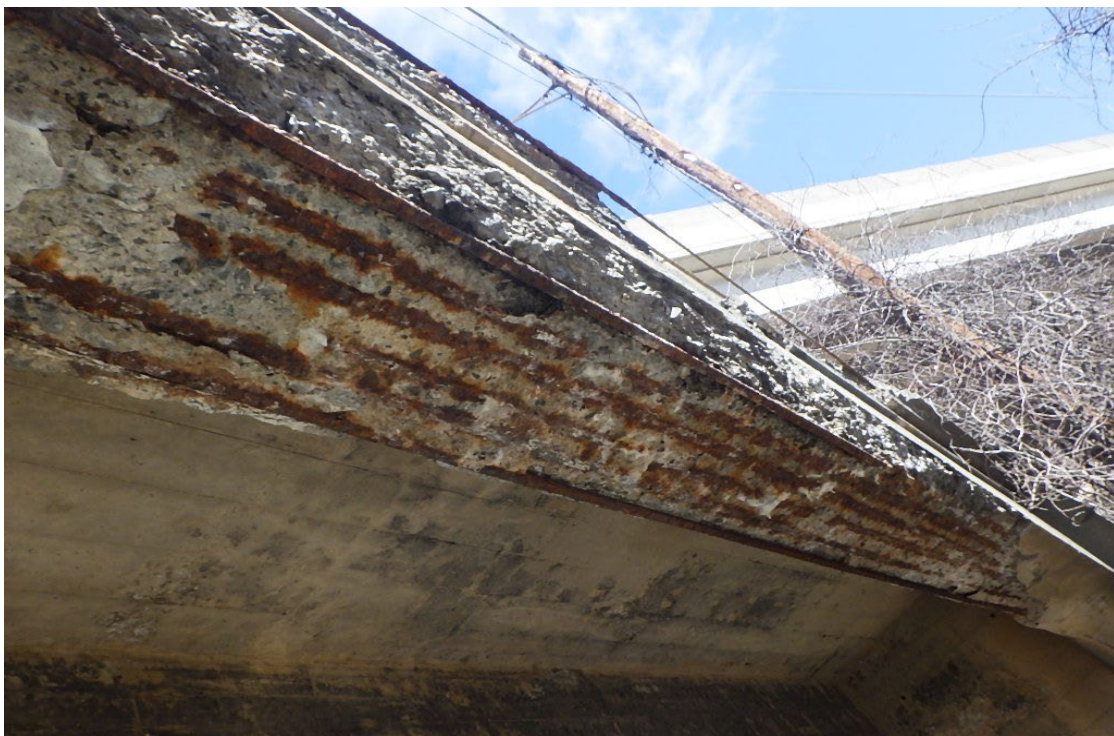
30. Beam 5 in Span 4 spall with six exposed longitudinal bars.

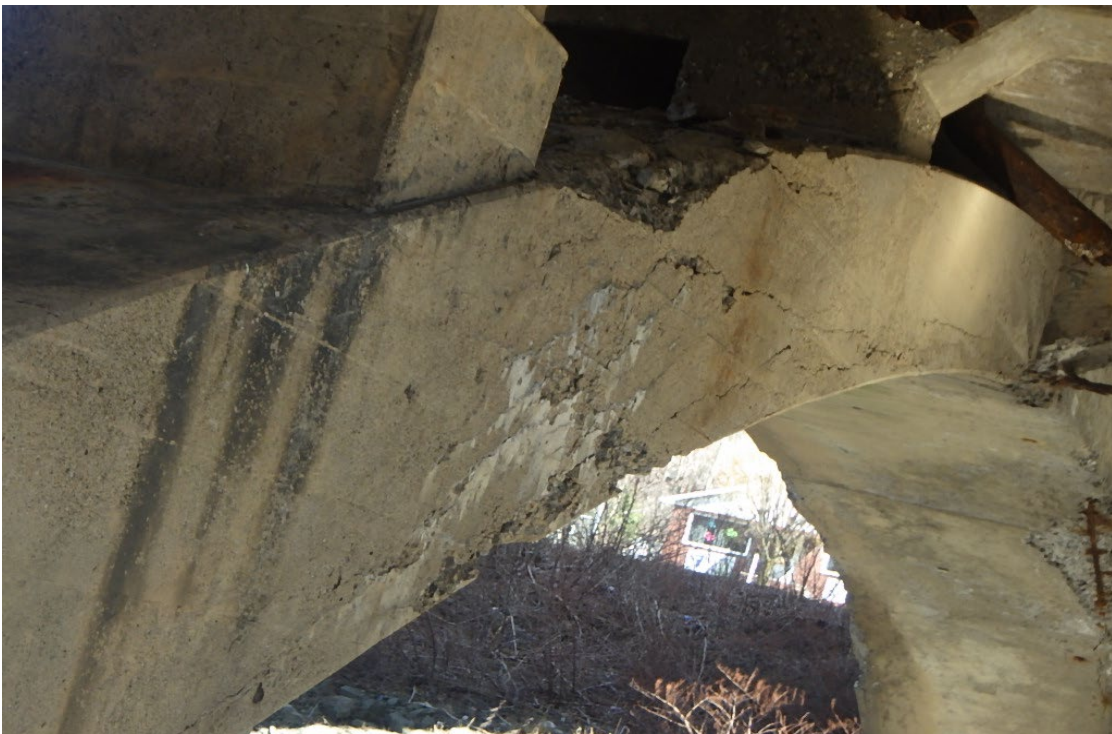
32. Cracks with delaminated concrete and spalling along the left arch rib.

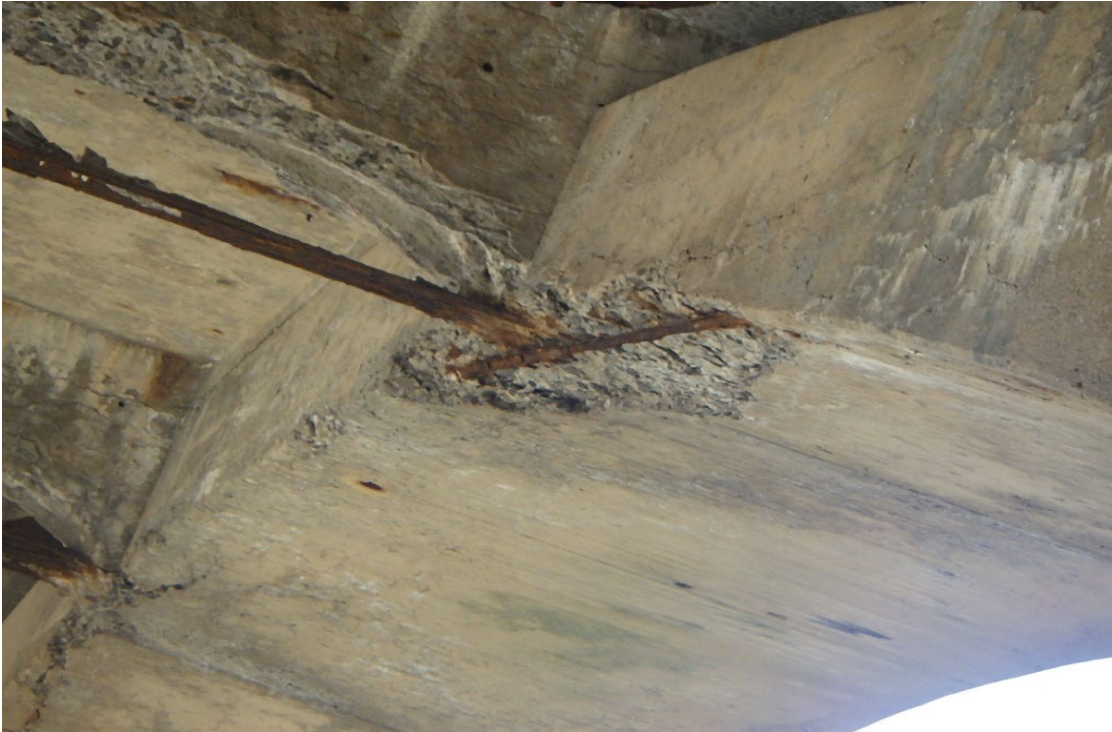
33. Left arch rib at mid-span with spall with exposed rebar.

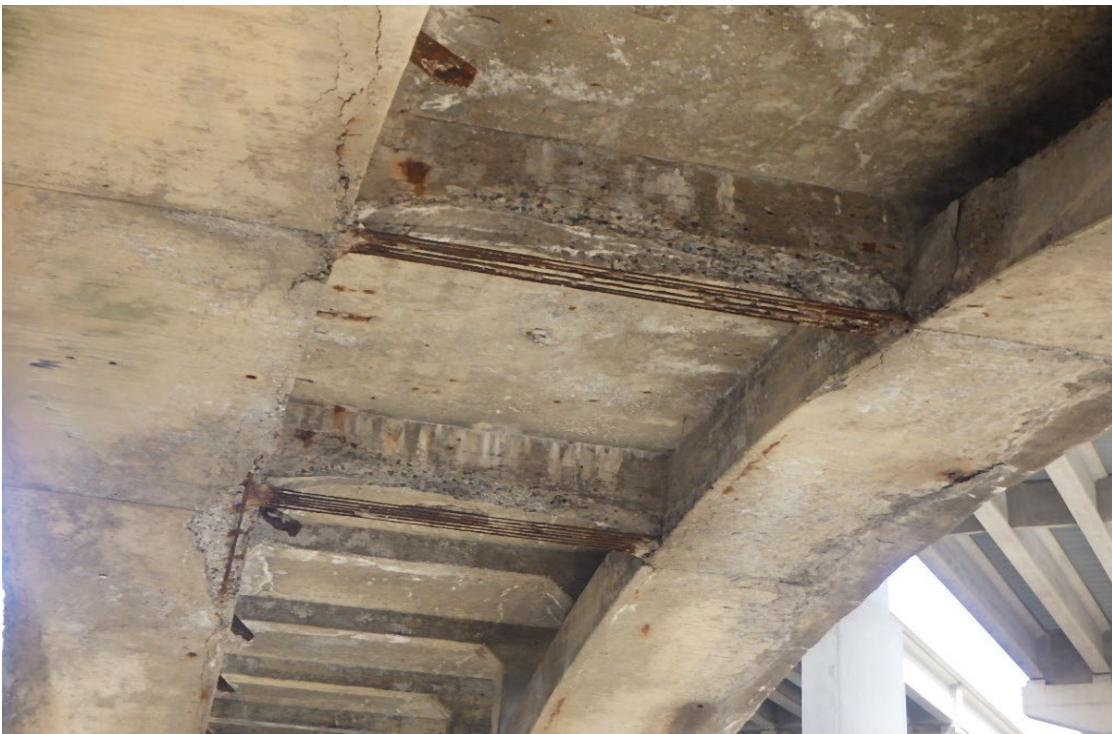
34. Floorbeams 5 and 6 in Span 5 with severe spalling across the bottom.

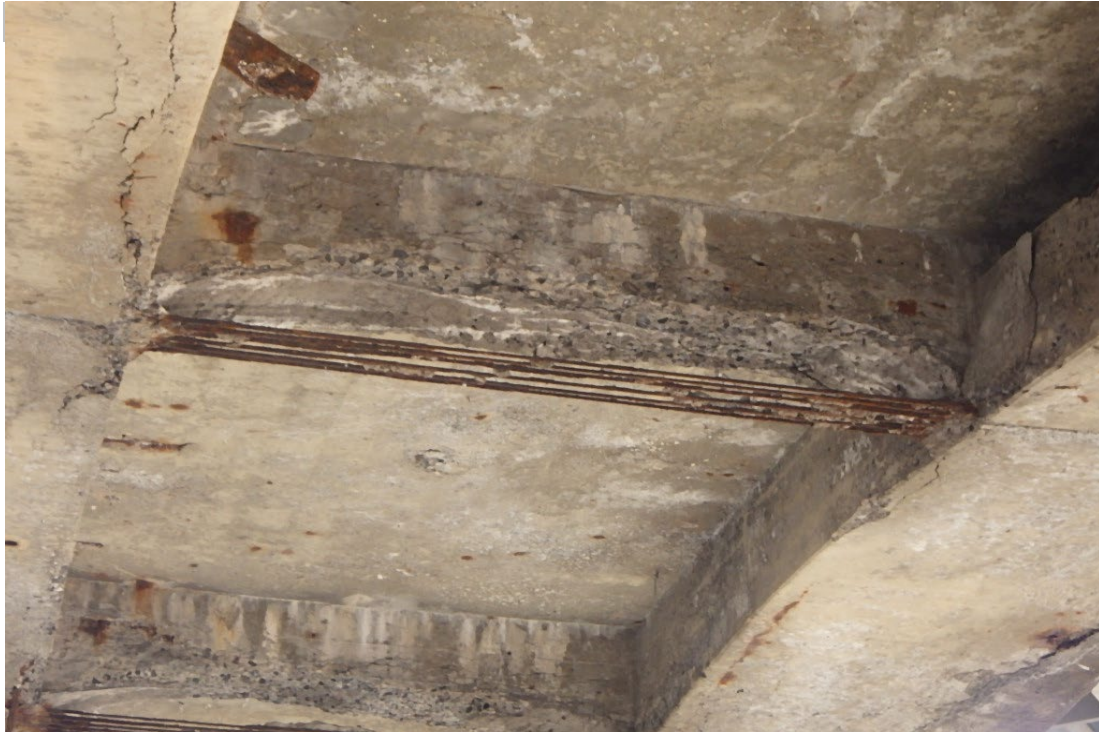
35. Close up of Floorbeam 5 with up to 12" gap between the concrete and bottom reinforcement.

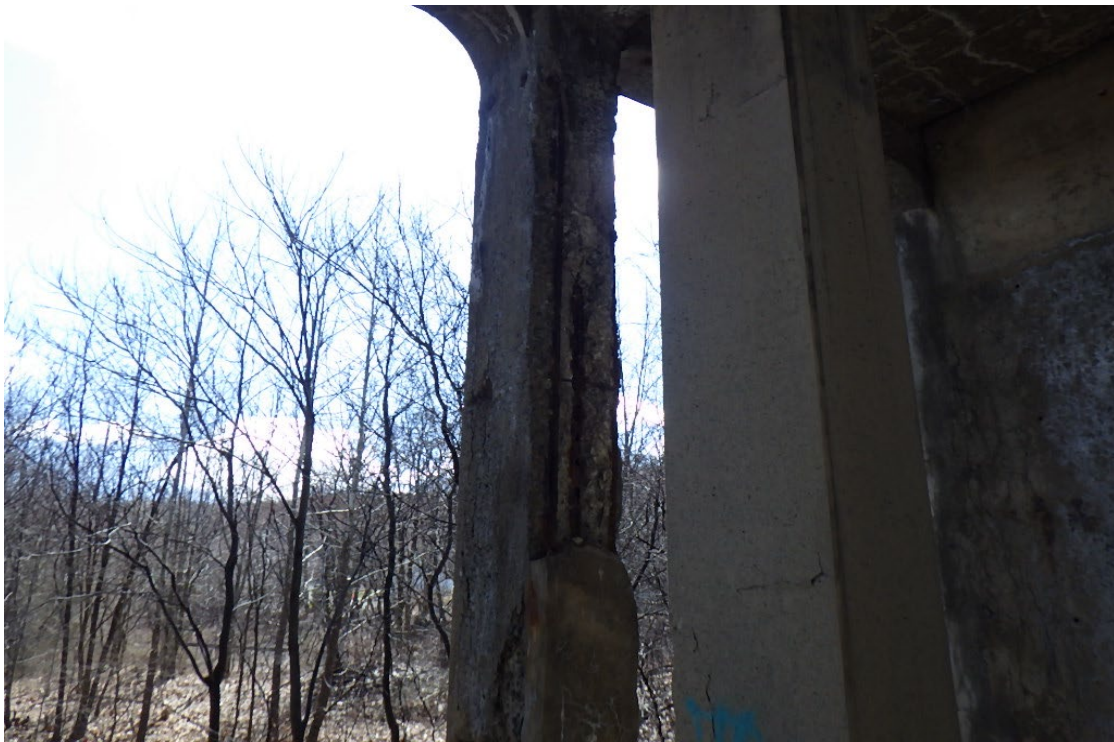
36. Full height spalling with exposed rebar to the right of Column 1.

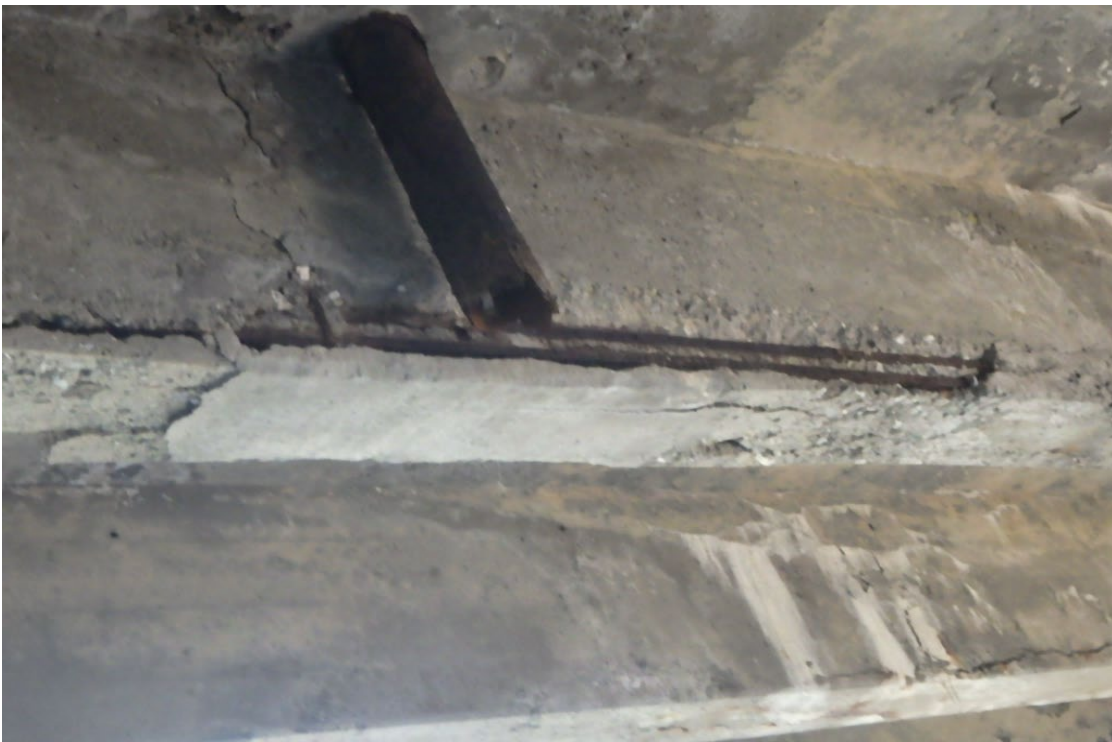
38. Spall with exposed rebar to Beam 2 at the drain outlet in Span 6.
