# 2023 Interim Bridge Inspection

PennDOT Bridge Inspection Report

Feature Carried: Mill Street

Feature Under: Delaware & Lackawanna RR

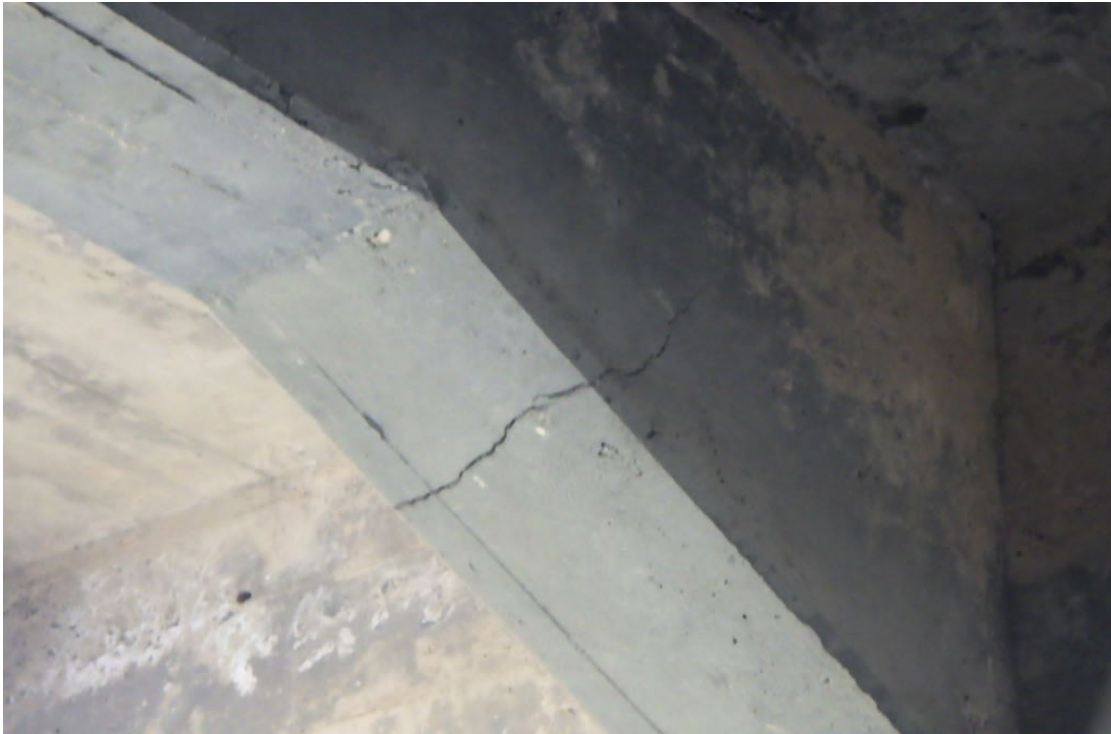
39. Shear crack in the haunches of the beams in Span 7.

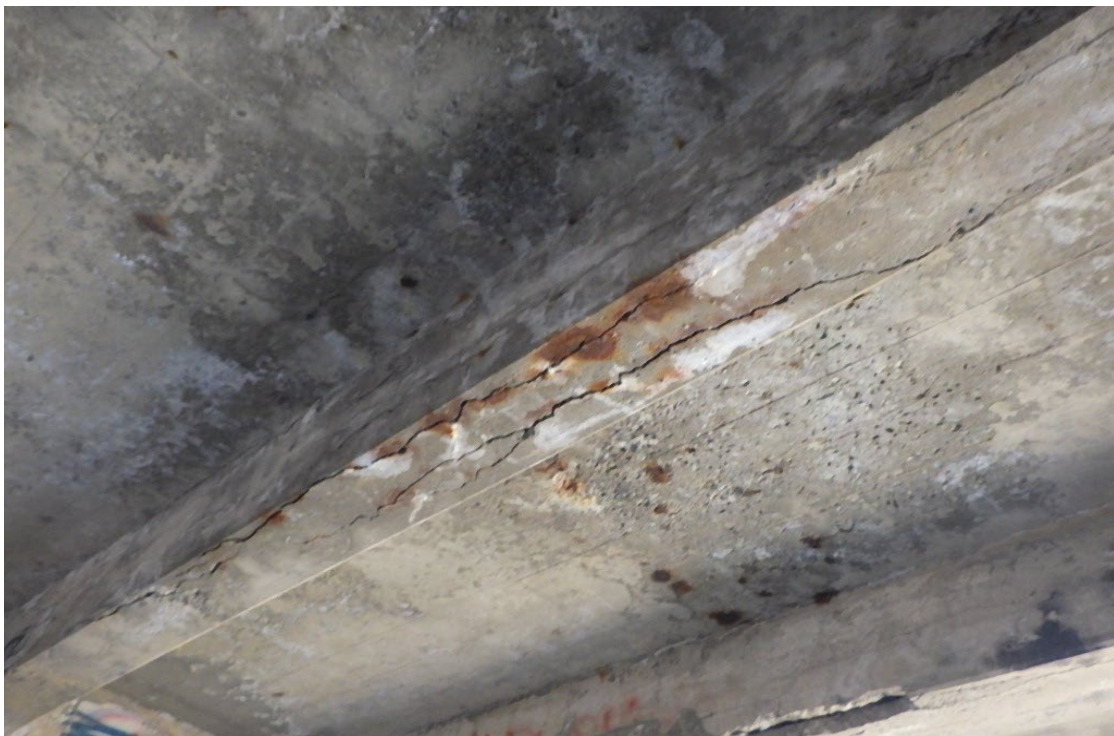
40. Cracks with rust and efflorescence and delaminated concrete in the bottom of Beam 3, Span 7.

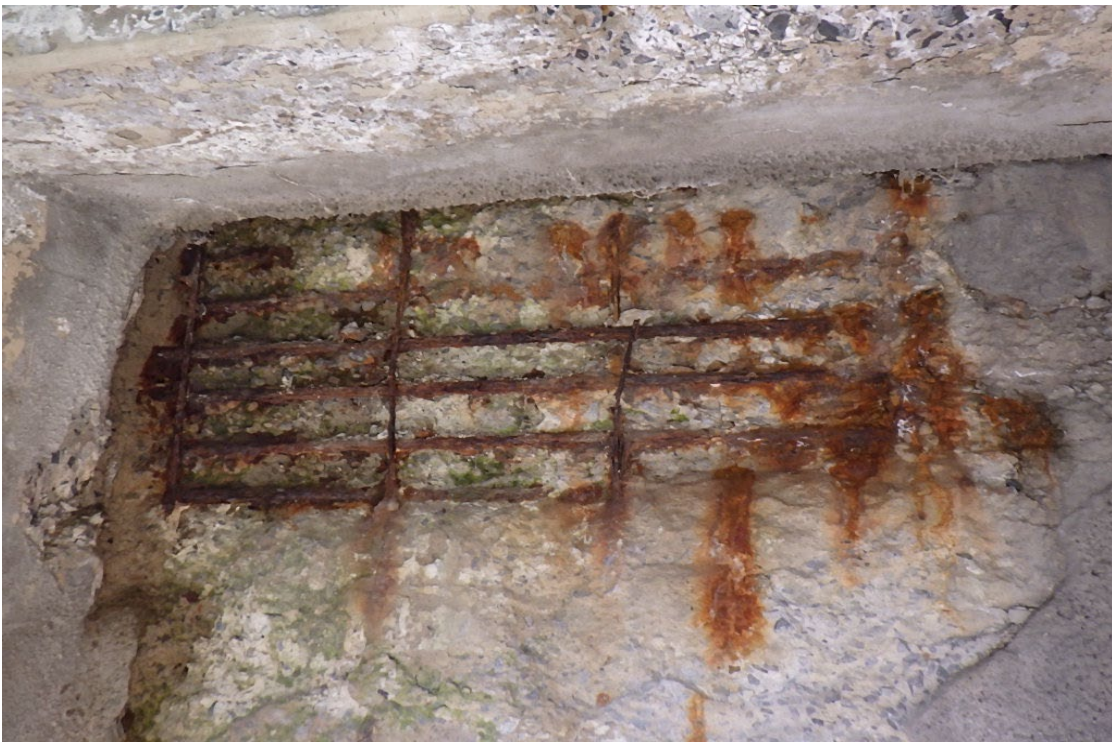
42. Spall with exposed rebar at the left end of the Near Abutment.

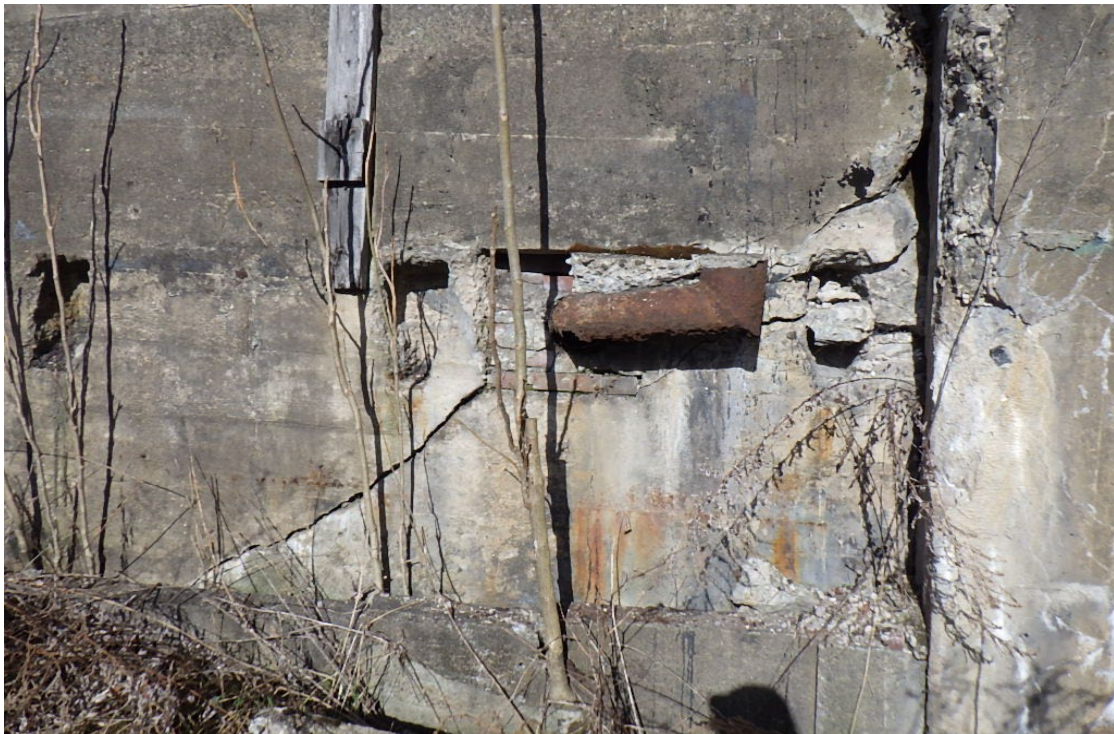
44. Wide diagonal crack in the Near Right Wingwall.

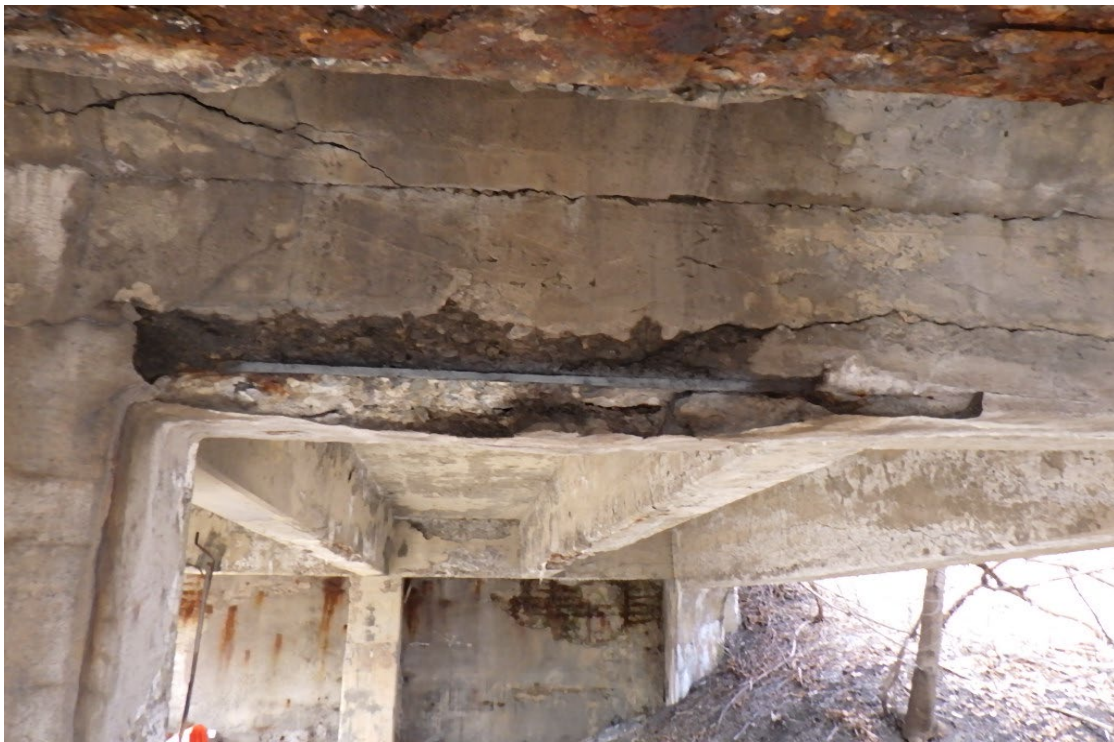
46. Spall with exposed rebar in the Pier 1 cap.

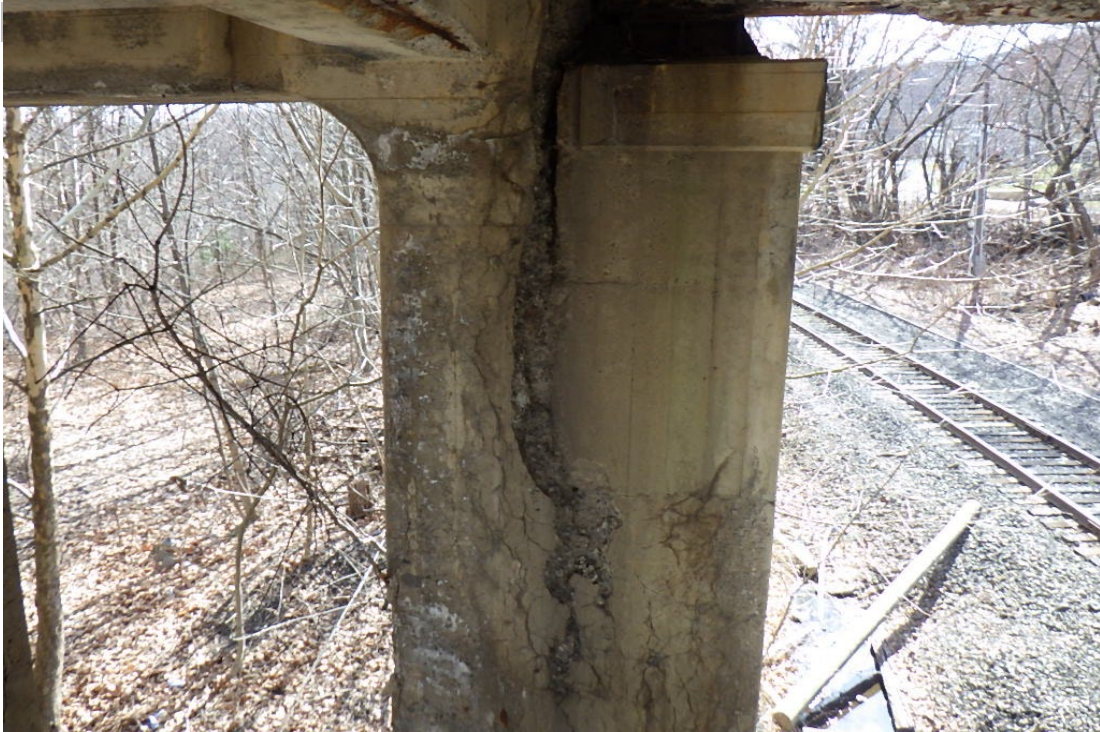
47. Cracks and spall in the left face of Column 2 at Pier 2.

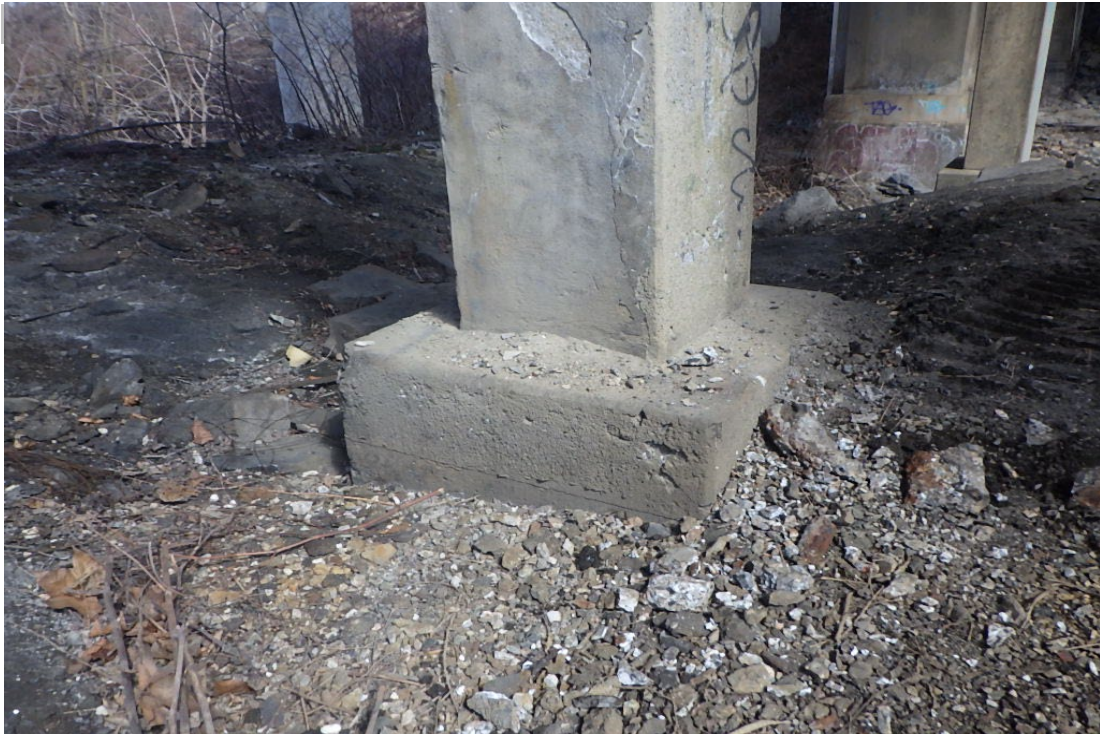
49. Exposed footings at Pier 3.

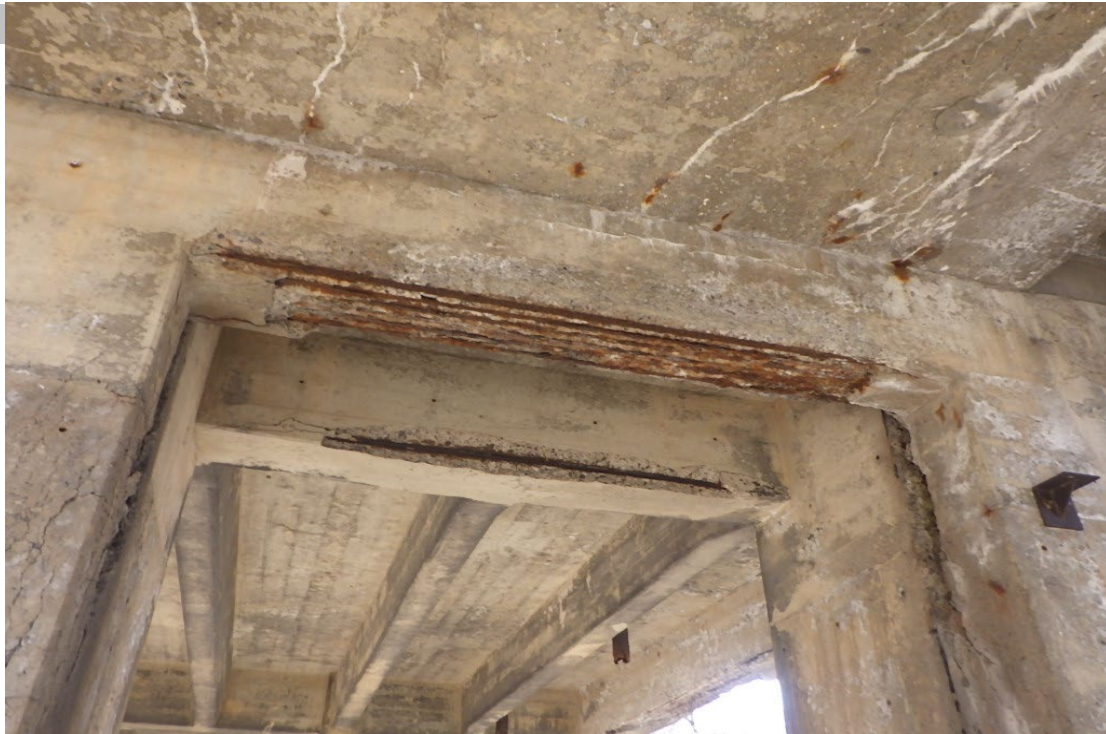
51. Spalls with exposed rebar in the cap at Pier 4.

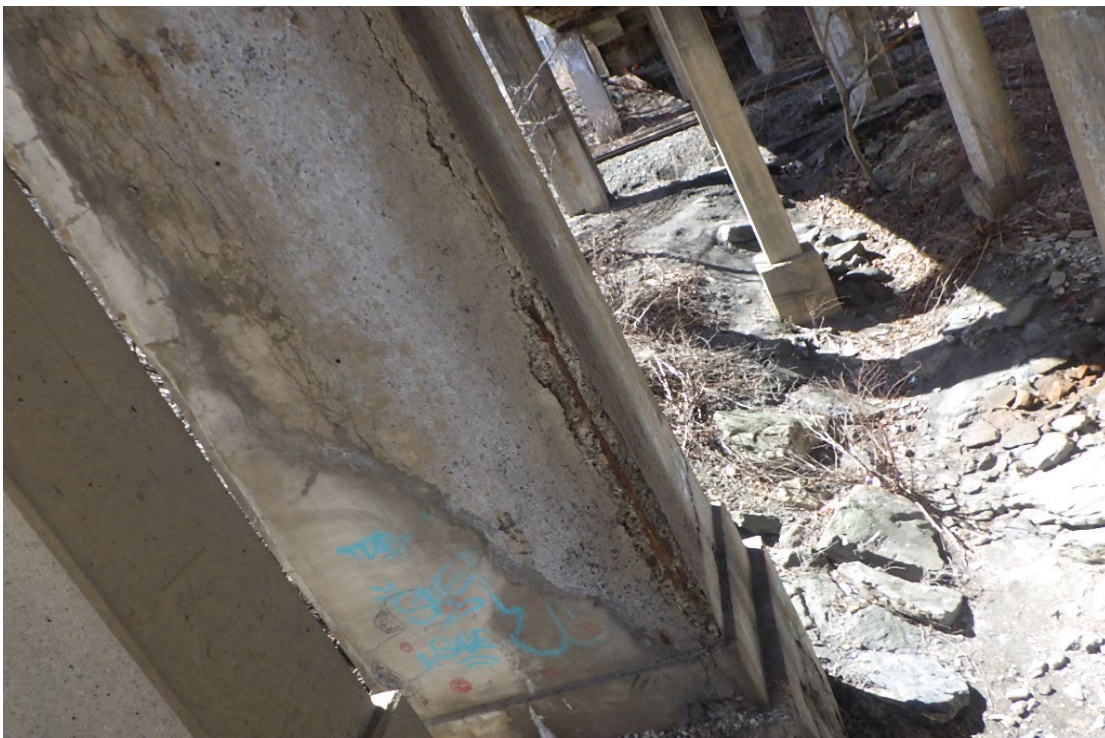
52. Spall with exposed rebar at the bottom of the right column at Pier 4.

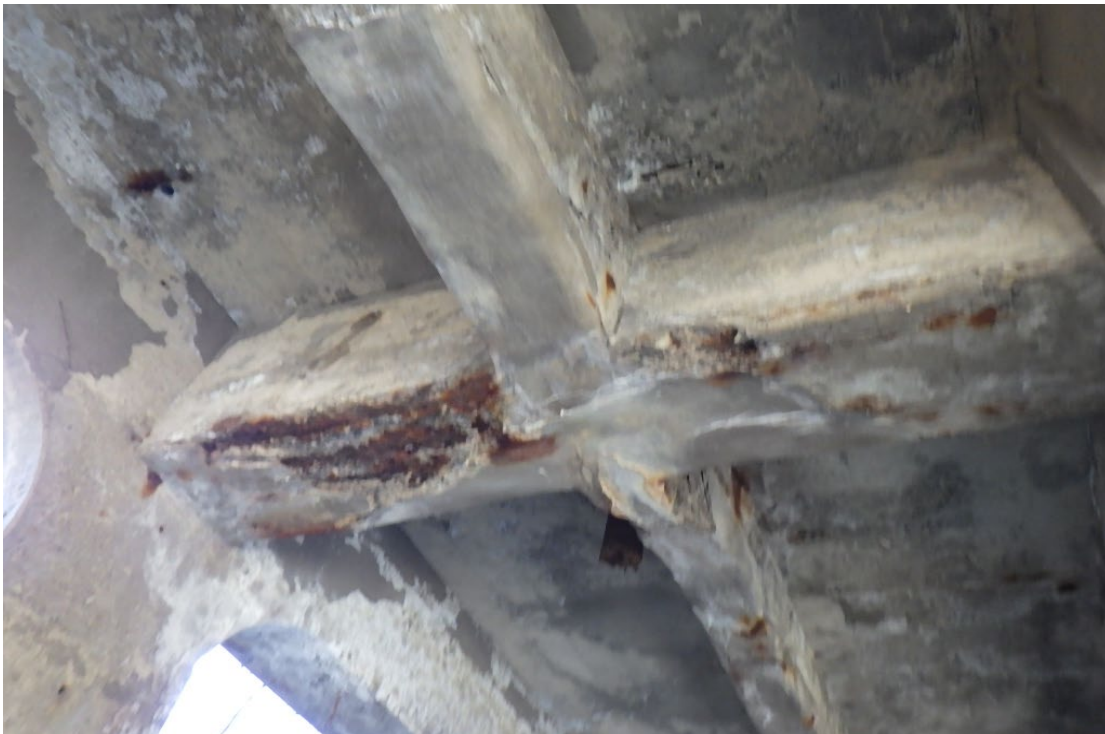
54. Spall with exposed rebar in the cap of Pier 6.

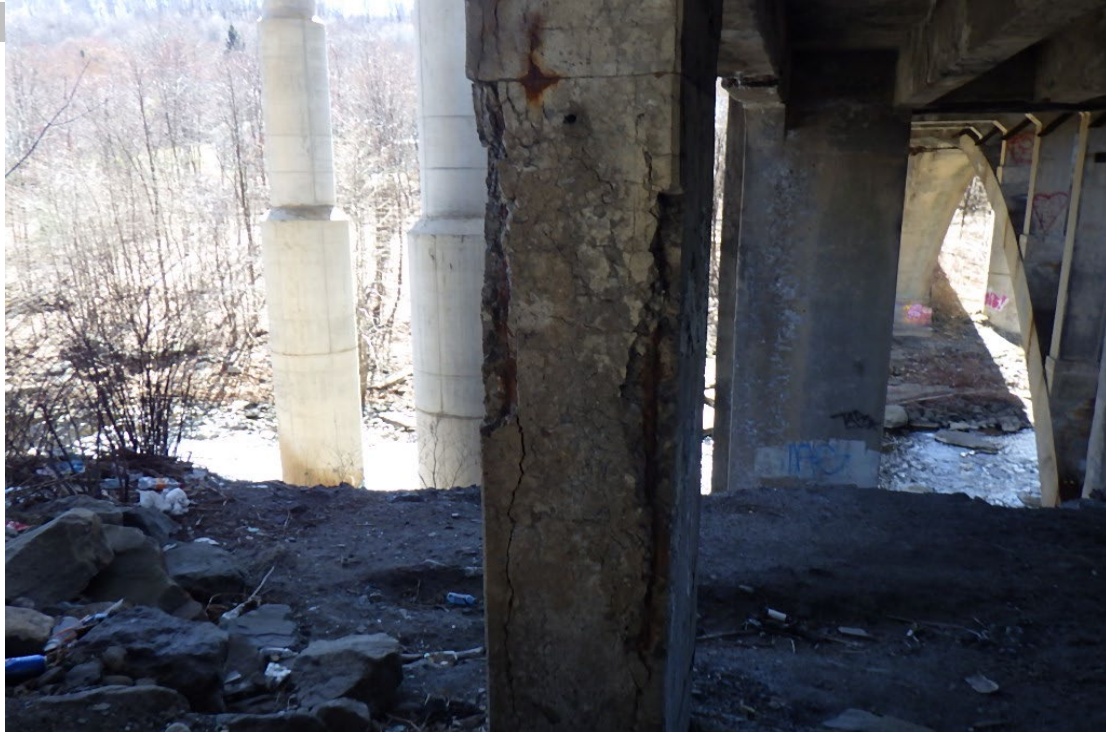
55. Cracks and spalls at the corners of Column 3 at Pier 6.
