# 2023 Interim Bridge Inspection

PennDOT Bridge Inspection Report

Feature Carried: Mill Street

Feature Under: Delaware & Lackawanna RR

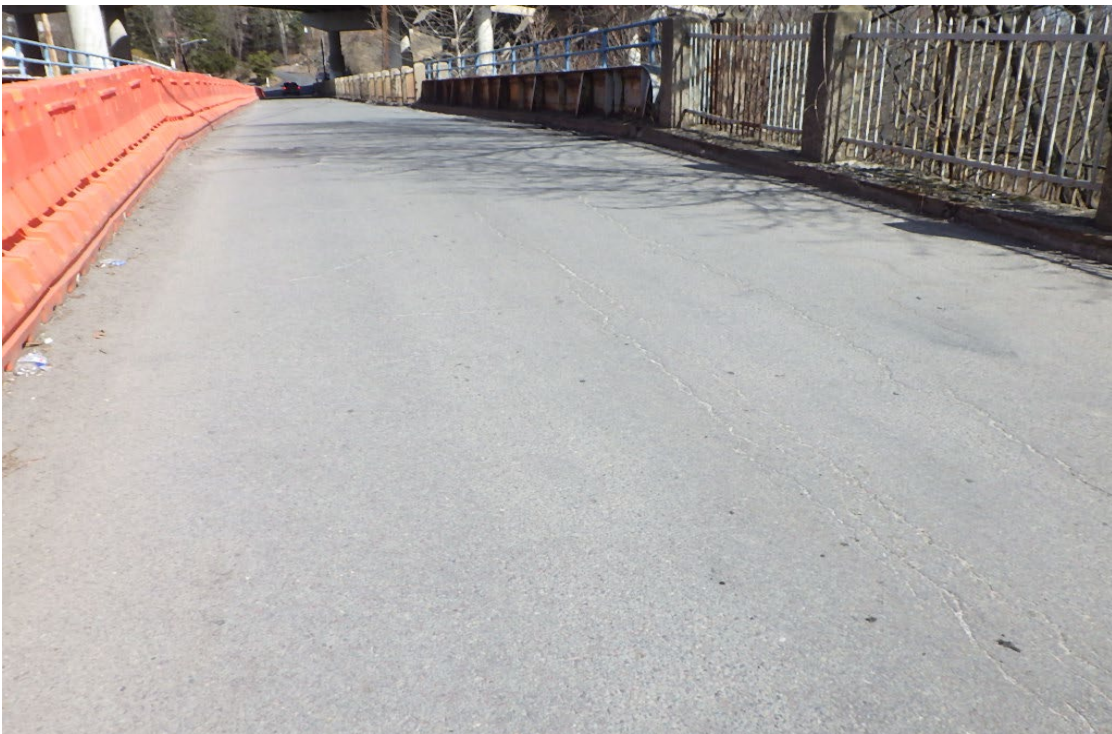
6. Top of deck, looking ahead.

- The top of deck is not visible due to the bituminous wearing surface.
- The sidewalk on the left has transverse cracks throughout and random delaminations and spalls, some with exposed rebar. A barrier is in place along the left curblin and pedestrians are restricted from the sidewalk on the left by chain link fences. The curbs along the right exhibit cracks and spalling with areas of exposed rebar.
- The underside of the deck has moderate to heavy scale, random spalls with exposed and heavily rusted rebar, hairline to fine cracks with efflorescence and rust, and areas of delaminations.

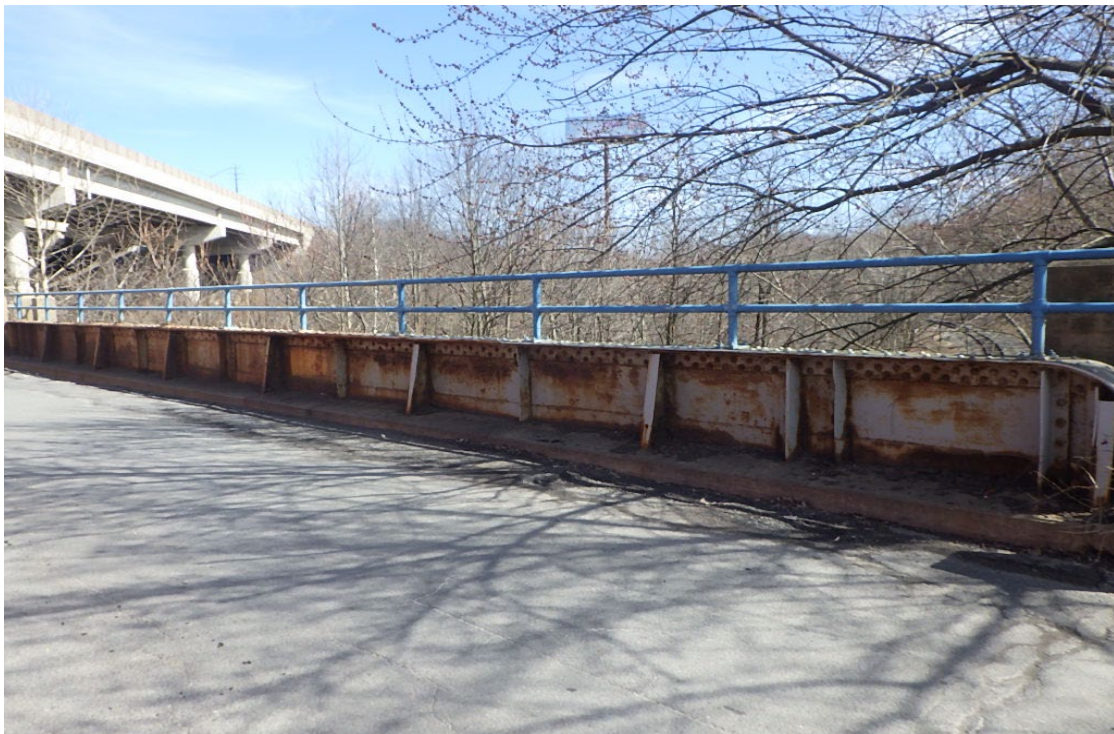
- Span 2 exhibits moderate to heavy rust and pitting with areas of section loss to the girders and exposed flanges of the floorbeams. Above the deck, holes were found in several knee braces and stiffeners. The right through girder 7th knee brace is bent. The longitudinal web plate along the sidewalk is almost entirely rusted through at the far left end. The right through girder has a few holes in the web and section loss above the bearing at the near end. The fascia webs have pack rust at the longitudinal repair plate located at mid-height. Typically the bearing stiffeners have up to 100% section loss at the bottoms. The concrete encasement is spalling along the bottom flange of the girders and reveals bottom flanges with heavy rust and moderate section loss. Several of the floorbeams also exhibit spalling of the concrete encasement along the top and bottom flanges. Typically, the exposed areas of the bottom flanges have section loss with  $\frac{3}{8}$ " remaining at the toe and  $\frac{5}{16}$ " thick remaining across the underside of the flange. The worst case being Floorbeams 1 and 15 which are located under the deck joints. The steel girder bearings have heavy rust, pack rust and are almost fully expanded and appear frozen.

8. Span 2 right through girder and bridge railing, looking ahead.

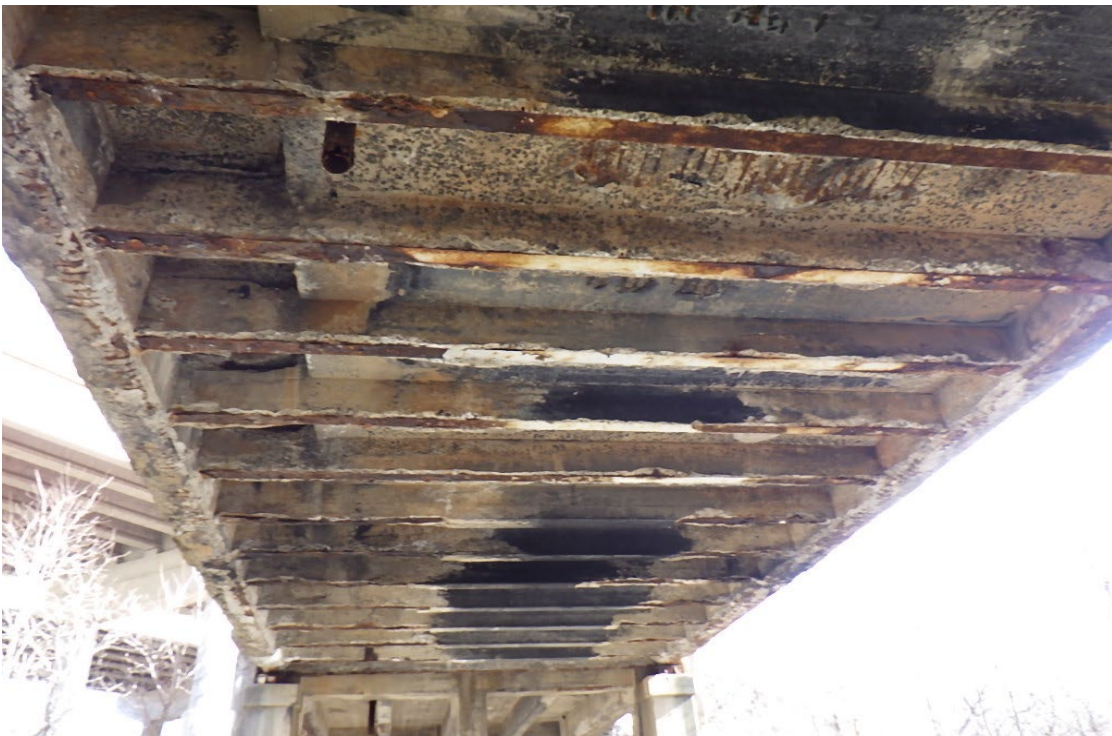
16. Underside of the superstructure, Span 2, looking ahead.

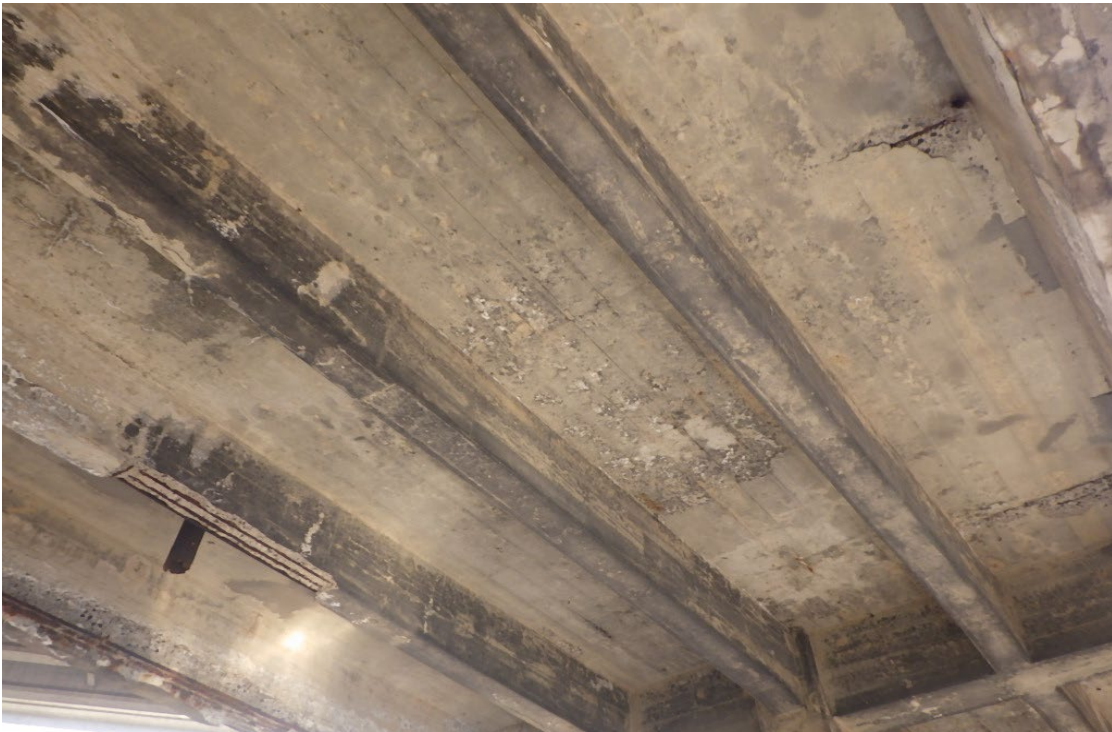
- The reinforced concrete T-beams exhibit full length longitudinal cracks with efflorescence and delaminations, heavy scale and spalls. Some of the spalls expose the bottom longitudinal reinforcement with typical moderate to heavy rust and some debonded bars. At the near end of Beam 5 in Span 3 and Beams 3 and 4 in Span 7, there are shear like cracks that extends thru the haunch at the near end. The worst case condition for the T-beam spans occurs in Span 3. Beam 1v exhibits spalling across the bottom that exposes six longitudinal bars which are partially to fully debonded. Similarly, Beam 2 has the bottom longitudinal reinforcement exposed and partially debonded throughout mid-span.

26. Underside of Span 3, looking ahead. Note that Span 4 is similar.

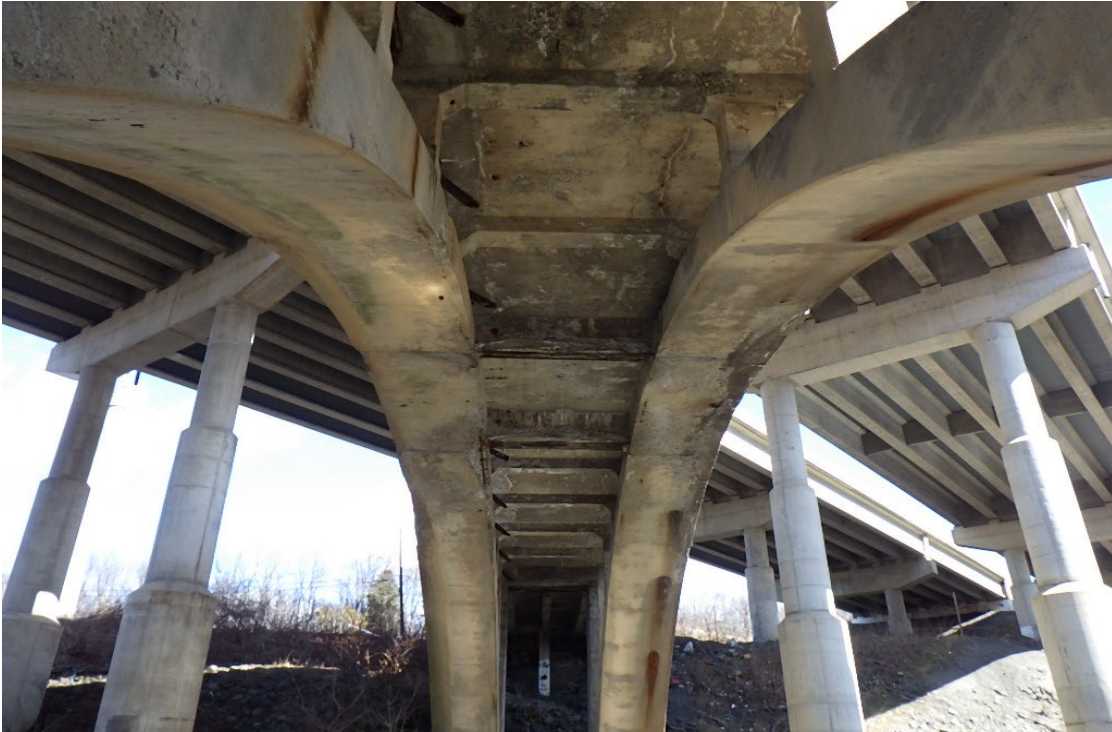
- The concrete open spandrel arch in Span 5 exhibits areas of cracking and scaling throughout. The arch ribs have delaminated areas and some spalls with exposed reinforcement. The concrete arch columns have wide cracks with delaminations and spalls with exposed rebar. Typically, the floorbeams have random cracks and vertical and diagonal shear cracks adjacent to the arch columns. Floorbeams 5 and 6 exhibit severe spalling and concrete loss along the bottom exposing all longitudinal reinforcement. There is a 6" gap between the bars and the remaining concrete. The fascia beams have similar cracking, scaling and spalling with diagonal shear cracks found at several locations.

31. Underside of Span 5, looking ahead.

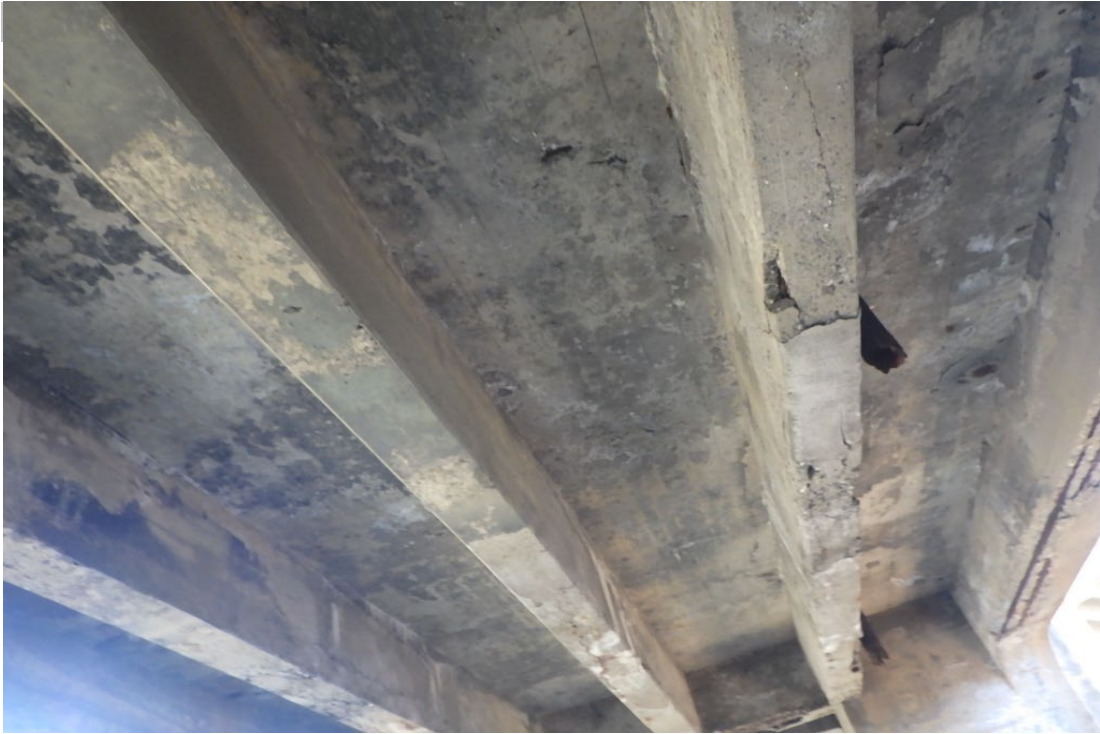
37. Underside of Span 6, looking ahead. Note that Span 7 is similar.

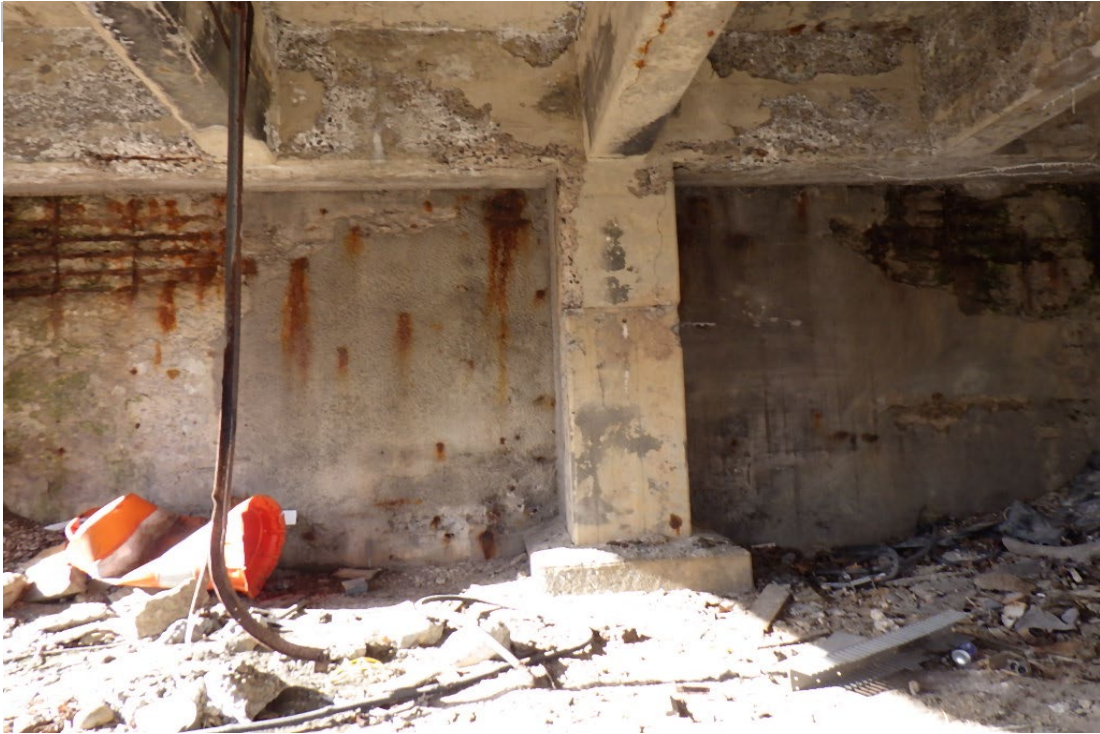
41. Near Abutment.

- The substructure consists of reinforced concrete abutments, piers, and wingwalls.
  - The abutments consists of three concrete columns with a concrete cap beam and concrete wall. Typically, the caps and columns have delaminations, spalls and cracks with efflorescence. The top of the footings are exposed at Near Abutment Columns 2 and 3. The concrete wall has heavy spalling with exposed rebar throughout. The Far Abutment also has a few spalls with exposed rebar and minor to moderate scaling.

B744802		Repair spalls and seal cracks in abutments							
	2	CY	@	\$2,230.00	per	CY	=	\$	4,460.00
RDCLSGN		Install hazard clearance signs at all corners							
	4	EA	@	\$100.00	per	EA	=	\$	400.00

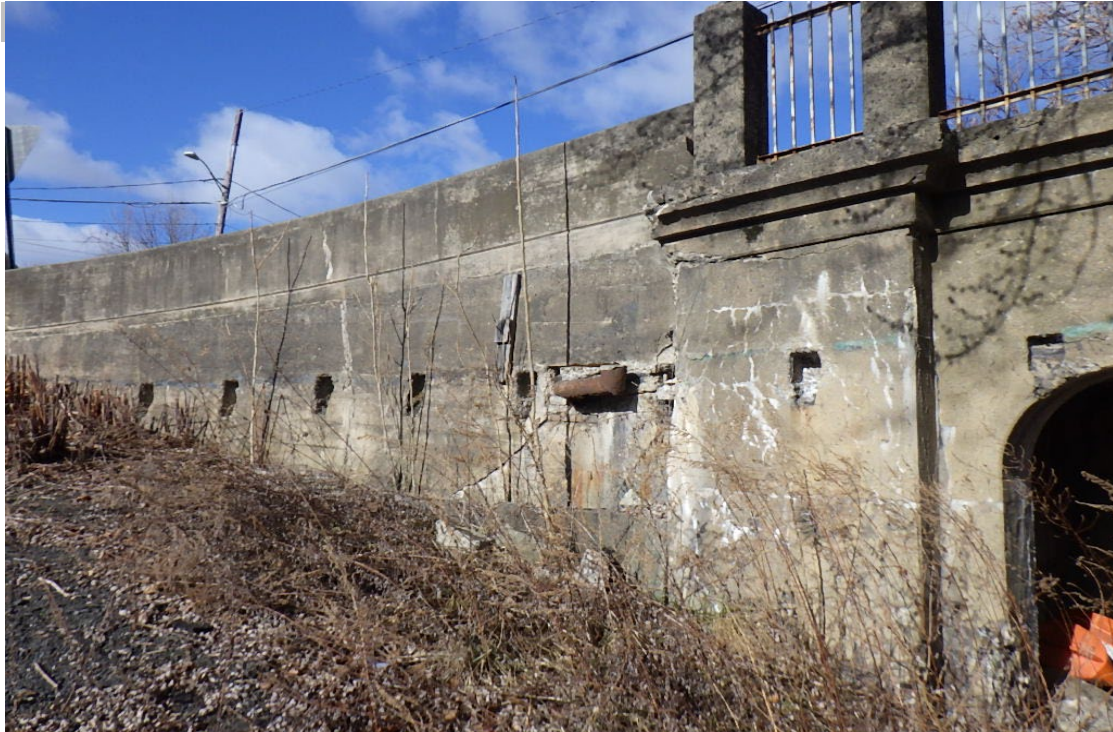
43. Near Right Wingwall.

- The concrete wingwalls at the Near Abutment have cracking and spalling. The Far Left Wingwall exhibits a full length horizontal crack with heavy spalling and the Far Right Wingwalls has a ½" wide crack with spall at the fixed end.

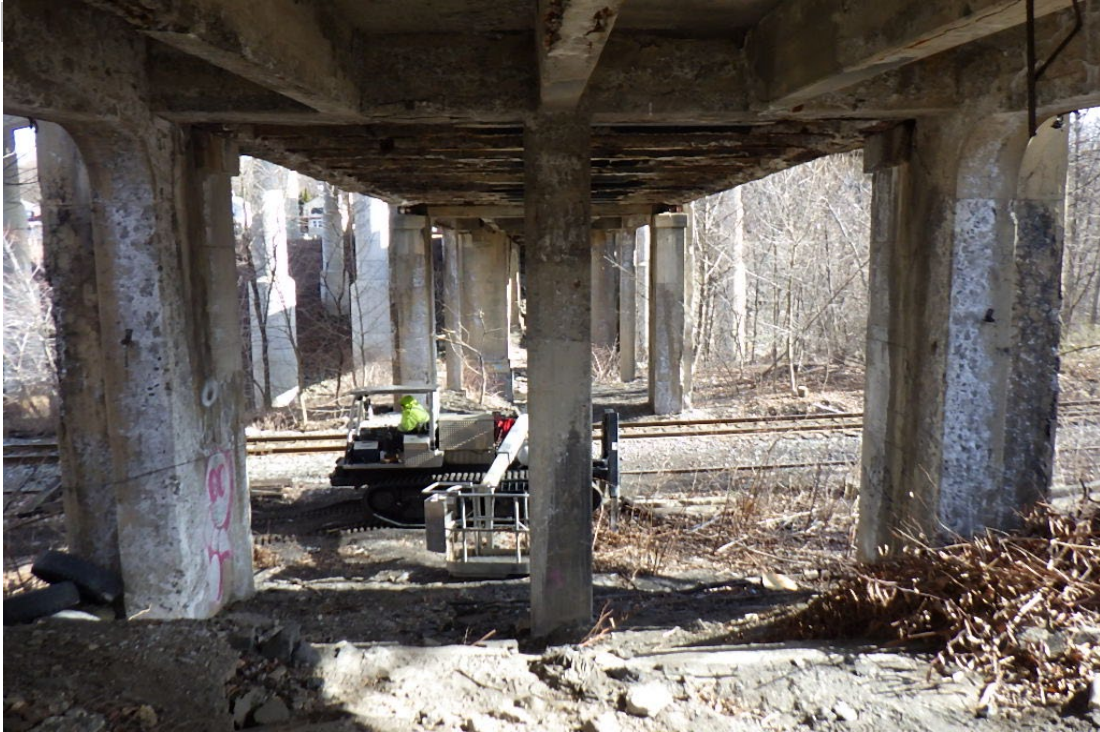
45. Pier 1, looking ahead.

- The concrete pier columns exhibit scaling, ¼" wide cracking, delaminations and spalls with exposed rebar. The random gunite repairs have cracking with spalls. Typically, the pier caps have cracking, delaminations and spalls with exposed rebar. At Piers 4 and 5, the caps have increased deterioration due to the active seepage from the deck. The footings are exposed at Piers 2, 3, 4 and 6 due to drainage runoff. Some of the footings exhibit cracking or minor

D744802		Repair spalls, delaminations, and cracks in piers							
	13	CY @ \$2,230.00 per CY	=	\$		28,990.00			
D744303		Repair spalled and holed through concrete deck							
	25	SY @ \$560.00 per SY	=	\$		14,000.00			
C744802		Repair spalls and seal cracks in wingwalls							
	2	CY @ \$2,230.00 per CY	=	\$		4,460.00

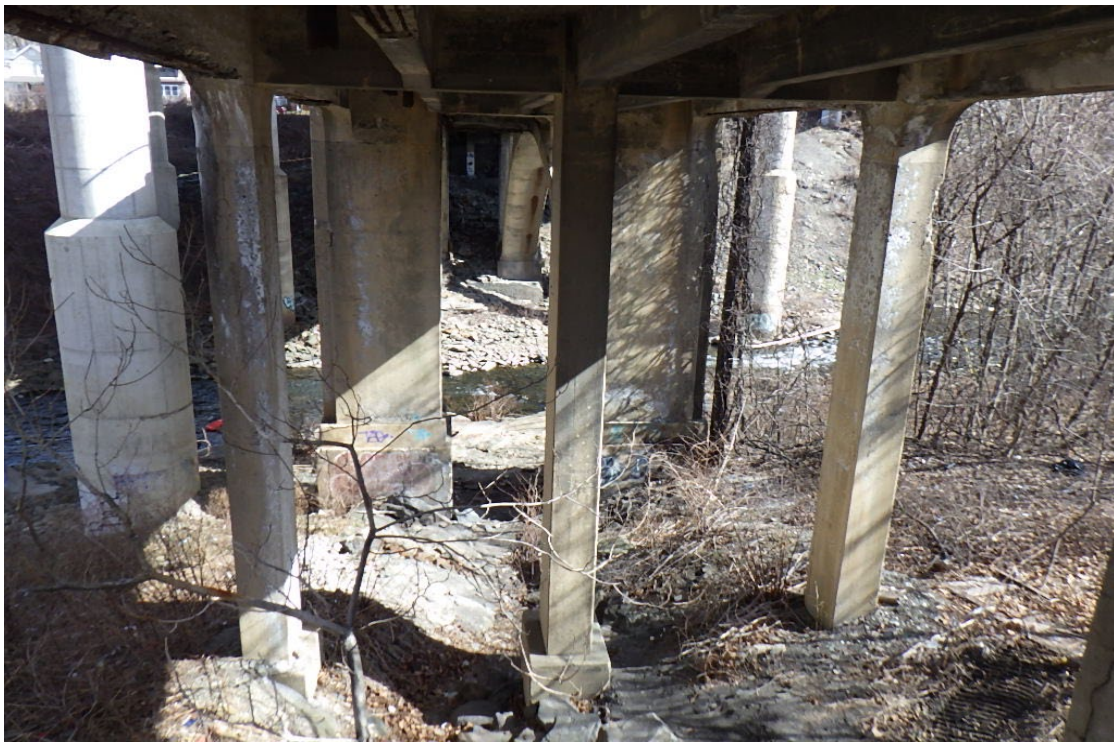
48. Typical pier for the T-beam spans. Pier 3 shown, looking ahead.

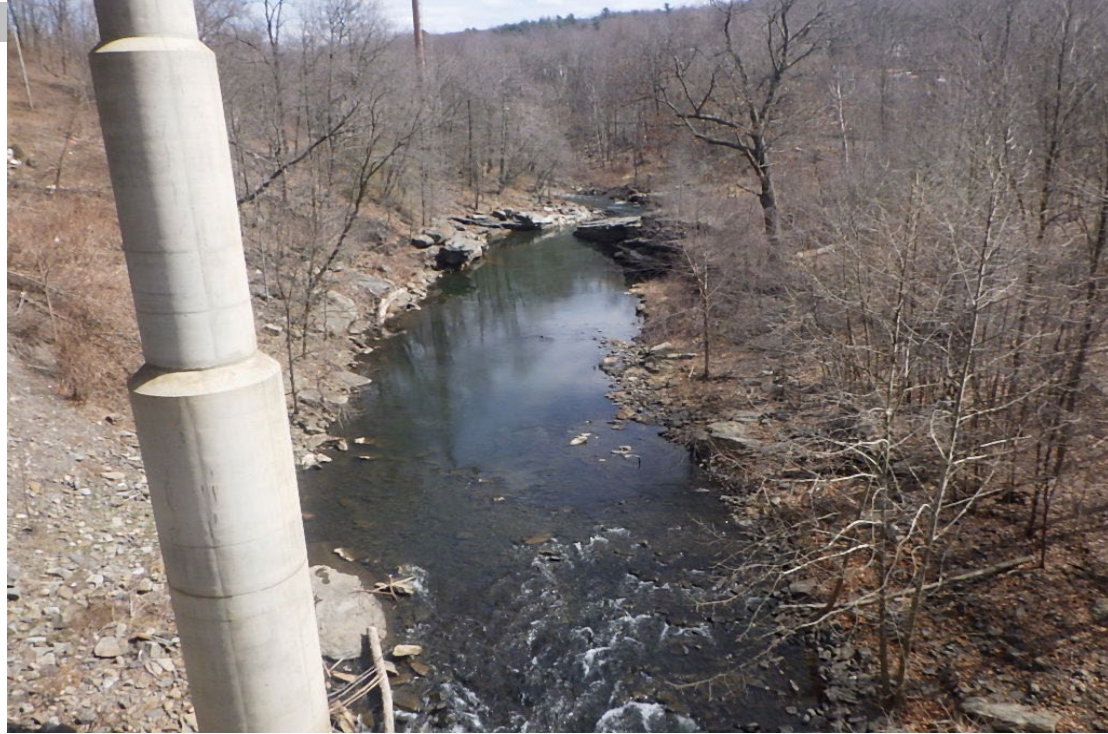
57. Upstream channel, looking right.

- The substructure units are not within normal flow, no scour was noted. The bridge is not considered Scour Critical and does not require a Scour Plan of Action.

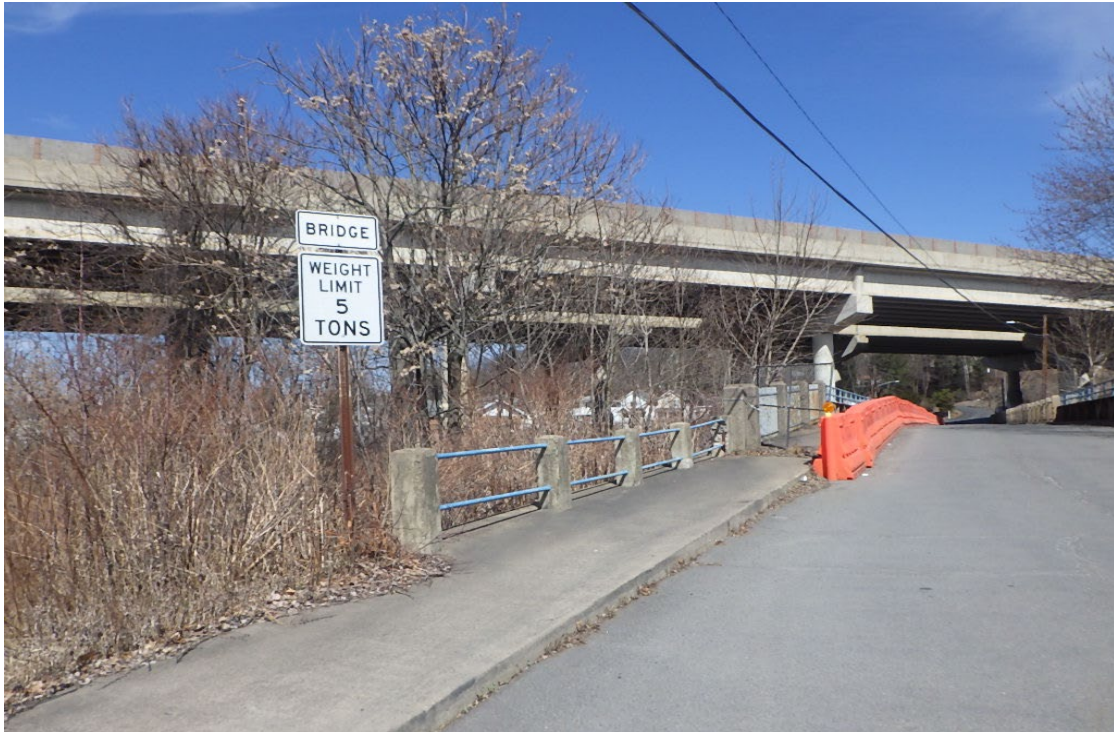
1. Near bridge site posting, looking ahead

The bridge is currently posted for 5 Tons. The weight limit signs are in place at the bridge and far advance. Signs are not required at the near advance because the bridge is at an intersection. A water filled barrier is in place along the left curblin. Because the bridge roadway width is <18', "Narrow Bridge" signs are required and in place at each bridge site. Hazard Clearance markers are recommended at each bridge corner, but are not in place.
